## Tomb no. GB o6 (Gabra no. M 22/SS (LH)) portico

## Tomb no. GB 06 (Gabra no. M 22/SS (LH)) portico

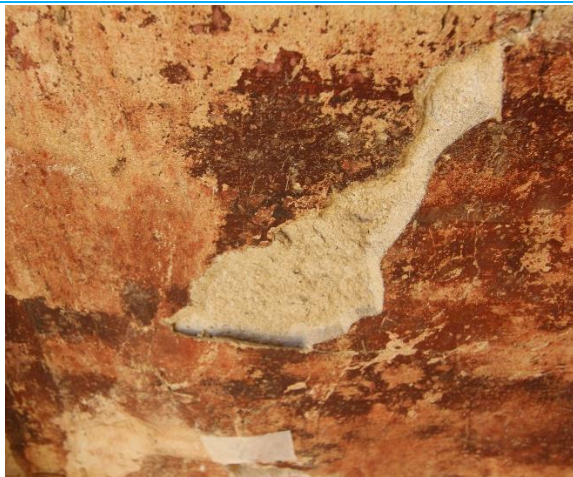
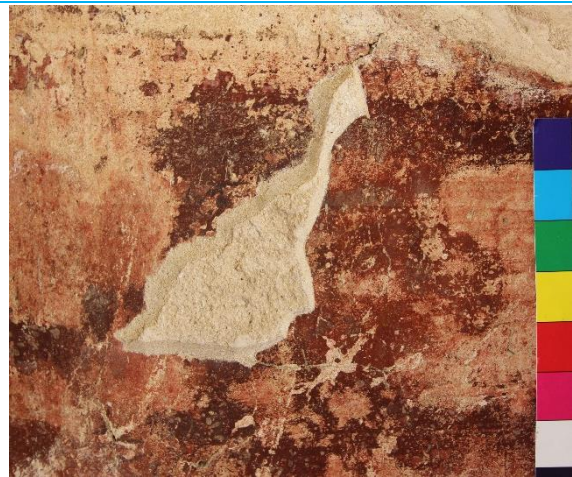
The lower parts of the walls are covered with desert sand. The plaster layers are partially lost and expose the sun dried clay brick masonry (adobe). Where visible, the adobe masonry shows a structurally destabilised and sanding surface. Parts of the joints are lost.

There is a layer of dust on the whole structure. The architectural surface is lined with cracks. There are traces of mechanical damage by vandalism. The plaster layers are detached from the adobe masonry, being endangered to falling off. Partially, the paint layers on the southern wall show deterioration phenomena like flaking.

An intervention is necessary to halt active deterioration and preserve the original plaster and wall painting.

The following steps of emergency measures were done in the field school of 2015. The architectural surface was dry cleaned by using soft brushes. For temporary protection fragile parts of the wall painting were masked by a facing of Japanese paper. Fragile paint layers have been structurally consolidated and re-stabilized.

The main goal was to stabilize the paint layer supporting plaster. The consolidation of the adobe masonry surface provided a solid structure for the treatments to follow. In addition, lost joints were infilled. The plaster layers were stabilized by edging detached fragments. The conservation mortar contains cellulose-ether as binder and is reversible. In outdoor areas the conservation plaster was finally structurally strengthened with a silica binder.

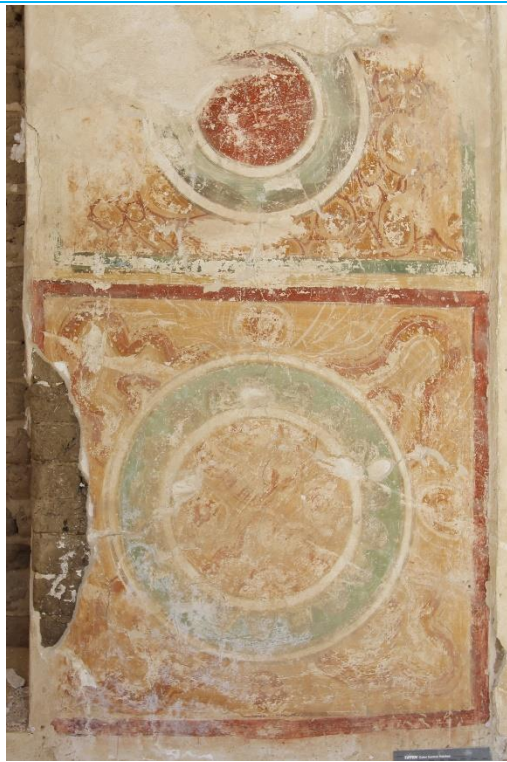
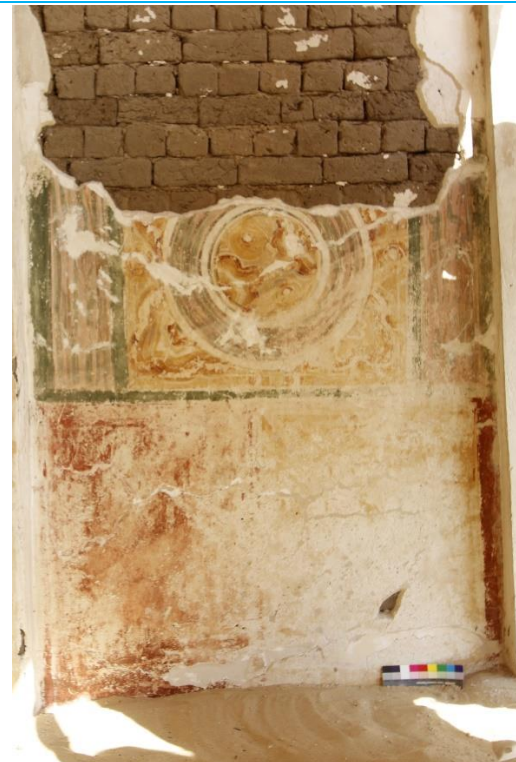
Condition after treatment

The most vulnerable areas of the artwork could be stabilized. Further treatment is essential to guarantee long-term conservation.

The wall paintings are exposed to the elements and human action. In this respect, it is desirable to establish a maintenance and monitoring programme for the future.
