Tomb no. GB 07 (Gabra no. M 22/SS (RH)) portico

Description of the interior design

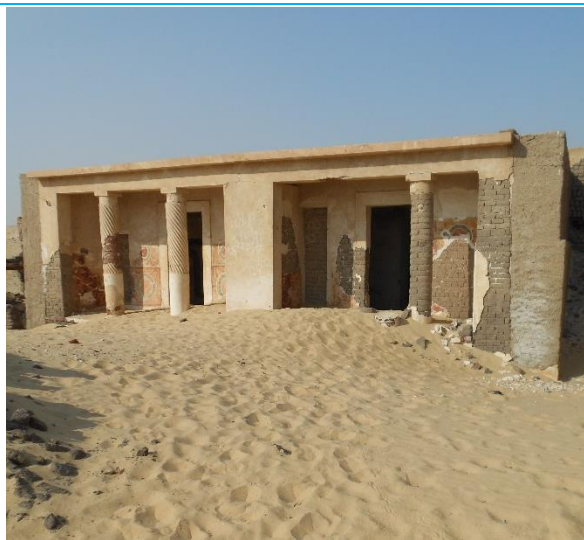
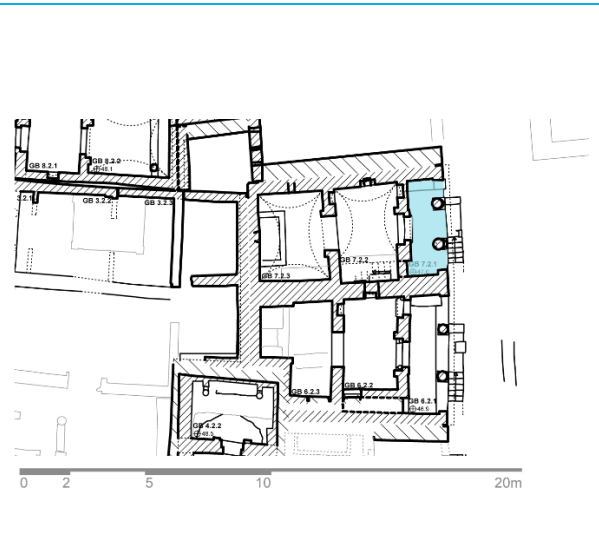
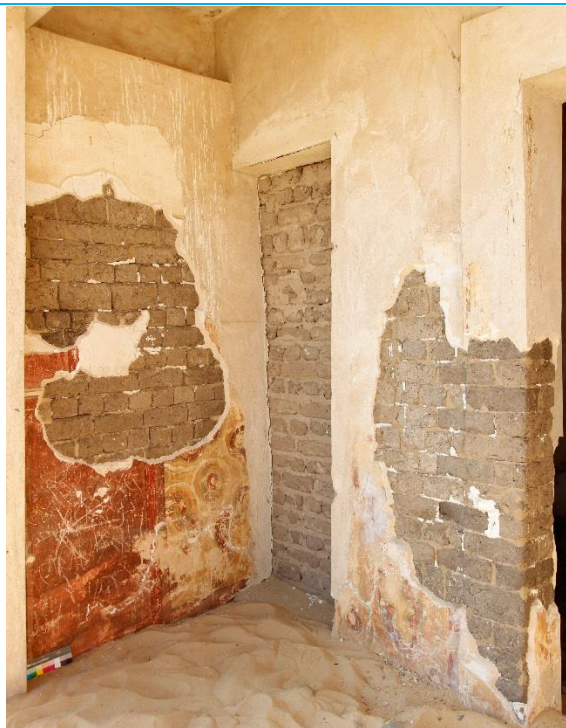
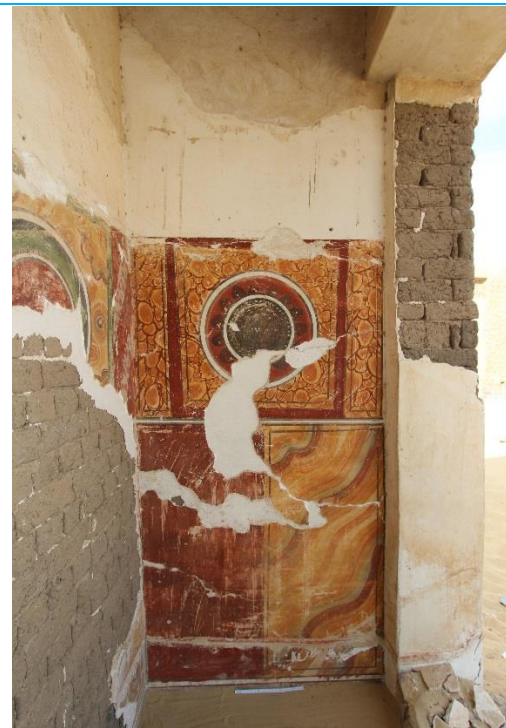
An open entrance room with originally two columns oriented to the east. The tomb house is built of adobe masonry. It was coated with a lime plaster layer, which was whitewashed in the upper half of the walls. Along the lower half of the walls a second thin plaster layer was applied and decorated with painted framed cassettes with imitations of stone incrustations. The polychrome painting was carried out directly on the smooth plaster surface.

The lost areas of the original plaster have been closed parallel to the reconstruction of the roof. The repair phase with white plaster was left unpainted.

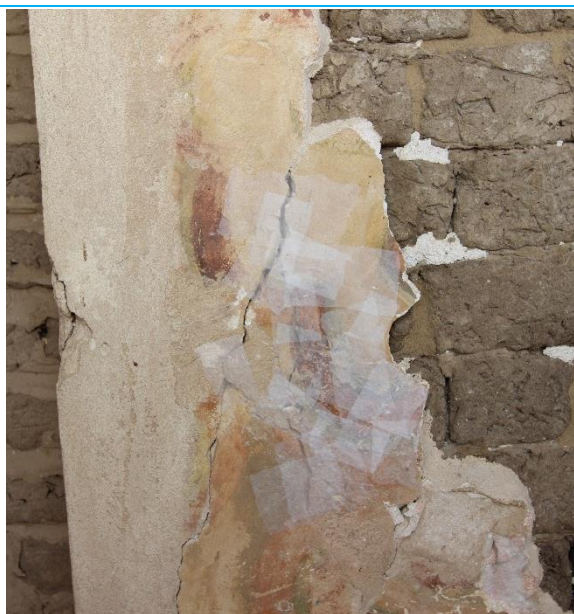
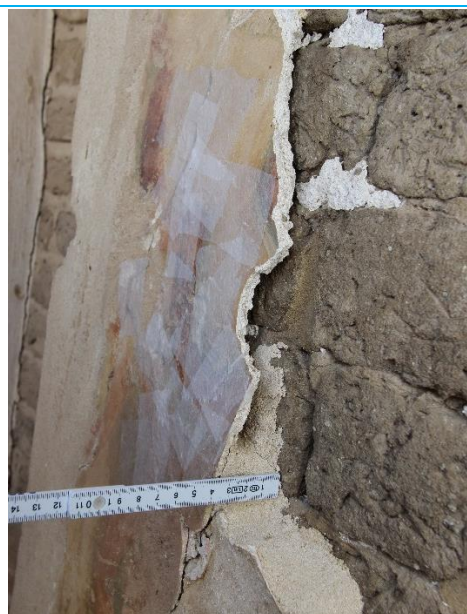
Condition before treatment

The lower parts of the walls are covered with desert sand. The plaster layers are partially lost and expose the sun dried clay brick masonry (adobe). Where visible, the adobe masonry shows a structurally destabilised and sanding surface. Parts of the joints are lost.

There is a layer of dust on the whole structure. The architectural surface is lined with cracks. There are traces of mechanical damage by vandalism, for example an imprint of a football on the middle of the northern wall. The plaster layers are detached from the adobe masonry, being endangered to falling off.

An intervention is necessary to halt active deterioration and preserve the original plaster and wall painting.

The following steps of emergency measures were done in the field school of 2015. The architectural surface was dry cleaned by using soft brushes. For temporary protection fragile parts of the wall painting were faced with Japanese paper.

The main goal was to stabilize the paint layer supporting plaster. The consolidation of the adobe masonry surface provided a solid structure for the treatments to follow. Additionally, lost joints were infilled. The plaster layers were stabilized by edging detached fragments. The conservation mortar contains cellulose-ether as binder and is reversible. In outdoor areas the conservation plaster was finally structurally strengthened with a silica binder.

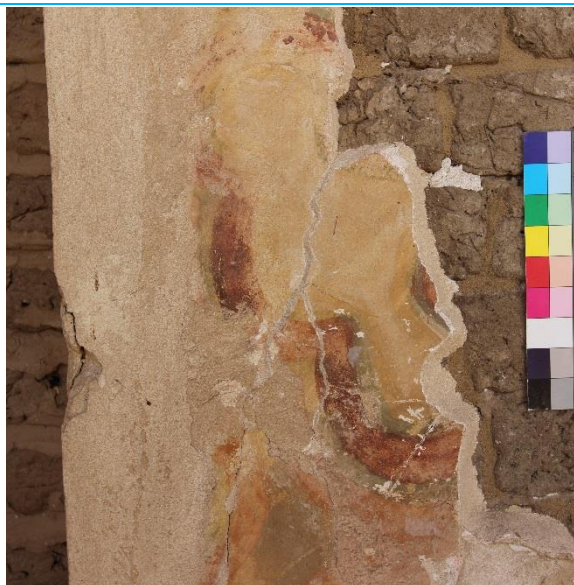
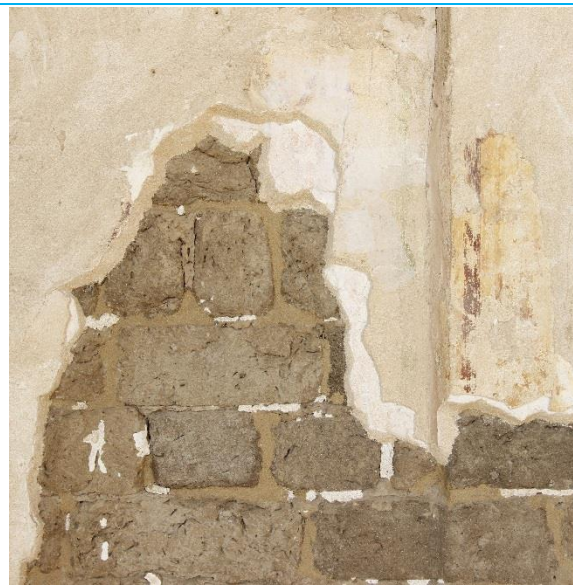
Condition after treatment

The most vulnerable areas of the artwork could be stabilized. Further treatment is essential to guarantee long-term conservation.

The wall paintings are exposed to the elements and human action. Today the second column is lost all the same. In this respect, it is desirable to establish a maintenance and monitoring programme for the future.
