Tomb no. GB 10 (Gabra no. M 03/SS) anteroom

Condition before treatment

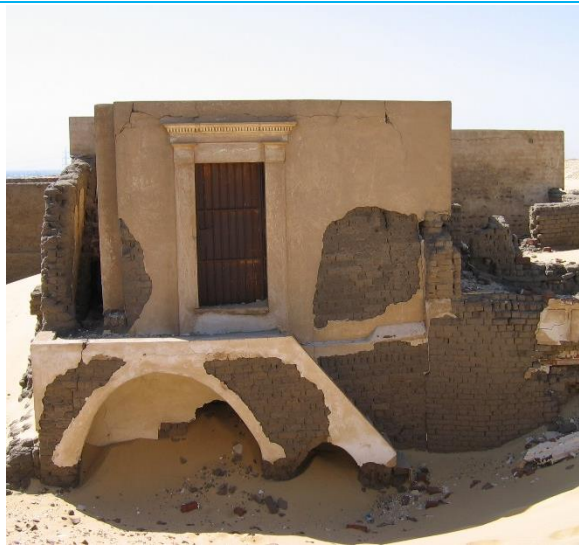
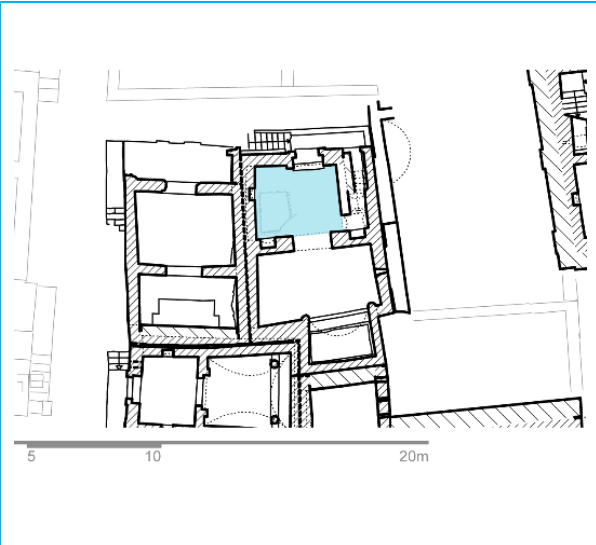
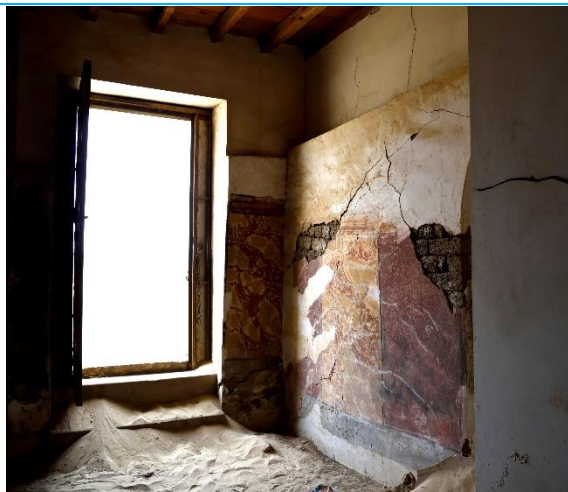
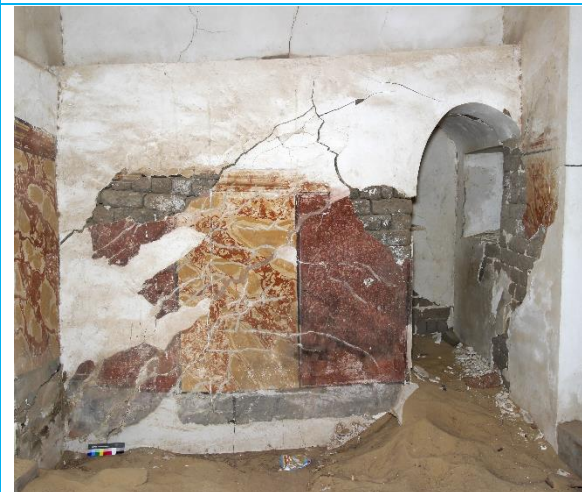
A tomb house made of adobe masonry. Today three rooms on the second floor are accessible. The entry of the first floor is covered by desert sand.

Inside the adobe masonry is coated with lime plaster. A whitewash on the top plaster layer serves as base for a wall painting. Mainly the eastern wall in this anteroom is decorated with imitations of stone incrustations.

The lost areas of the original plaster have been closed parallel to the reconstruction of the roof. The repair phase with white plaster was left unpainted.

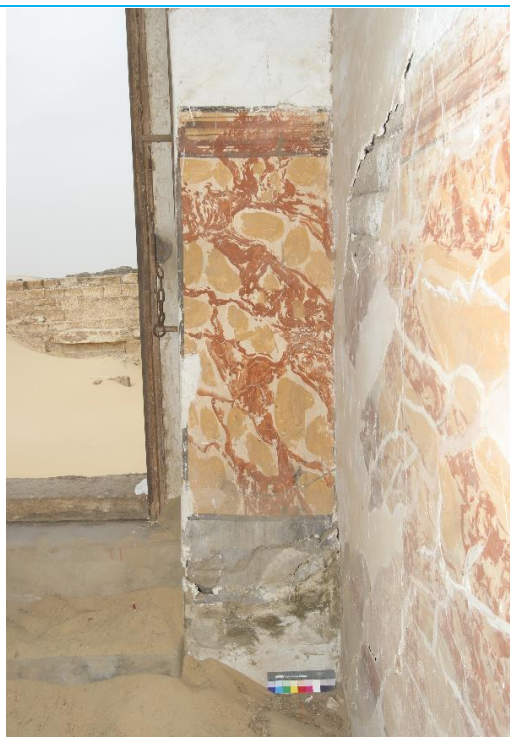
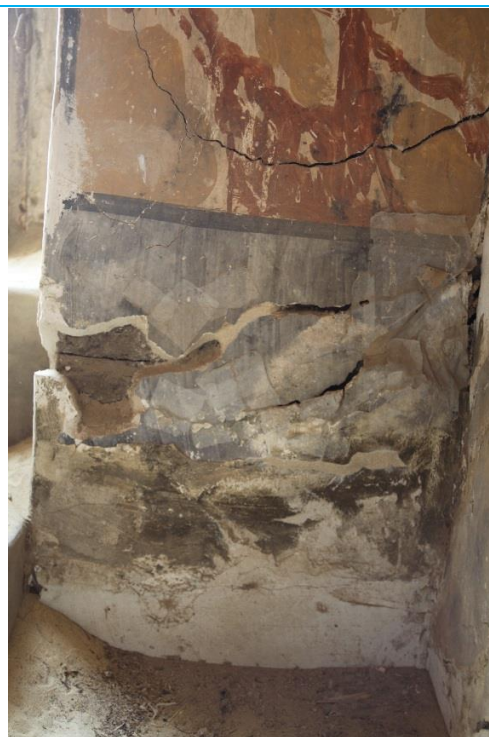
Not all areas of the floor on the second floor are safely accessible. The eastern wall of the anteroom is accessible. The plaster layer is partially lost and expose the sun dried clay brick masonry (adobe). Where visible, the adobe masonry shows a structurally destabilised surface. Additionally, parts of the joints are lost.

The architectural surface is lined with cracks. The plaster layers are detached from the adobe masonry, being on high risk to falling off. There is a layer of dust on all exposed structures.

An intervention is necessary to halt active deterioration and preserve the original plaster and wall painting.

The following steps of emergency measures were done in the field school of 2015. The architectural surface was dry cleaned by using soft brushes. For temporary protection fragile parts of the wall painting were faced with Japanese paper and cellulose-ether glue.

The main goal was to stabilize the paint layer supporting plaster. The structurally consolidation of the adobe masonry surface provided a solid structure for the treatments to follow. Additionally, lost joints were infilled. The plaster layers were stabilized by edging detached fragments. The conservation mortar contains cellulose-ether as binder and is reversible.

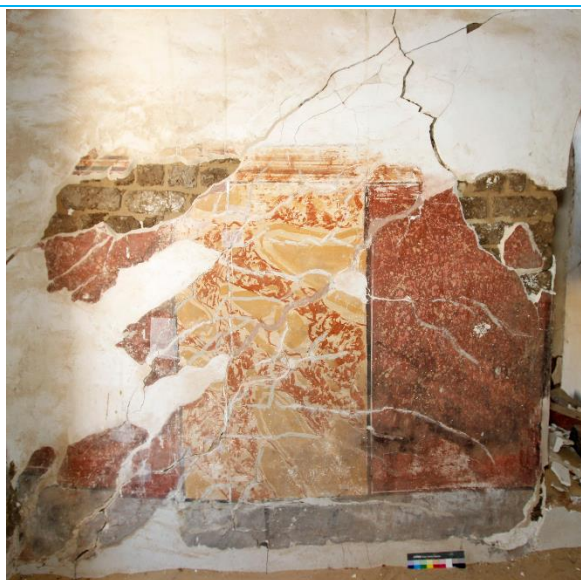
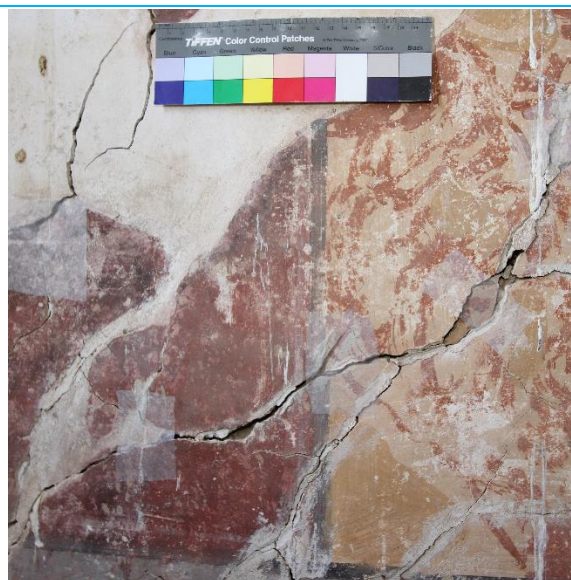
Condition after treatment

The most vulnerable areas of the artwork could be stabilized. The tomb house is protected by a lockable door.

Fragile parts of the wall painting, which could not be consolidated in the working campaigns, were faced with Japanese paper and cellulose-ether glue to keep in place. Further treatment is essential to guarantee long-term conservation.
