Tomb no. GB 13 (Gabra no. M 05/SS (LH)) anteroom

Tomb no. GB 13 (Gabra no. M 05/SE (LH)) outside

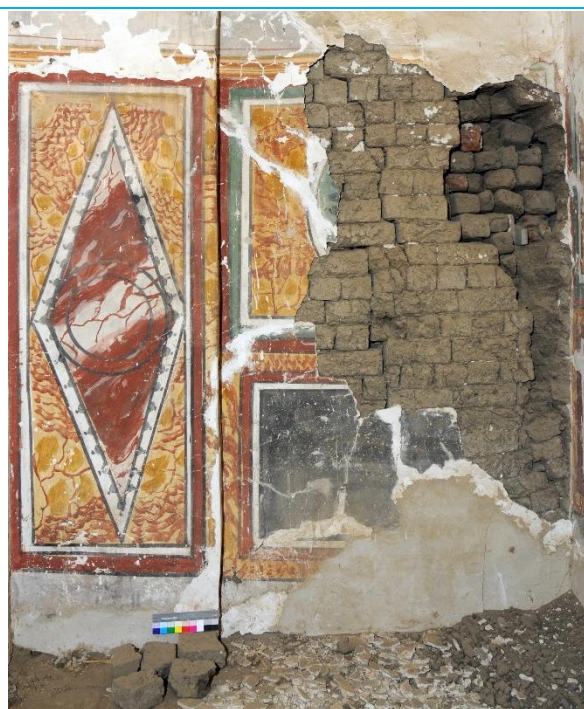
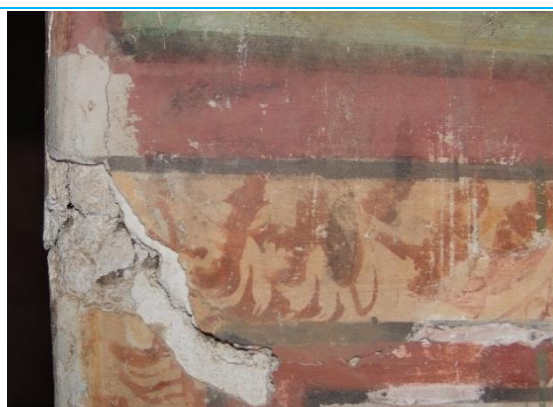
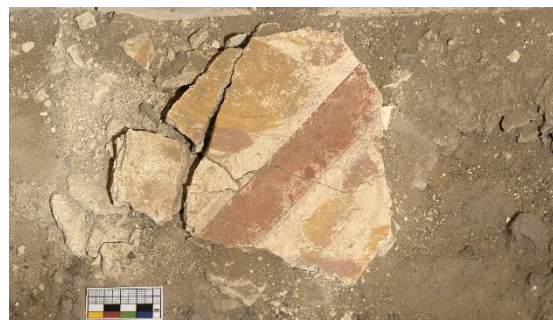
The plaster layers on the northern and eastern wall are partially lost and expose the sun dried clay brick masonry (adobe). Collapsed plaster fragments could be found on the floor. Where visible the adobe masonry shows a structurally destabilised and sanding surface. Parts of the joints are lost. In the northern-eastern corner is a hole in the wall bricked up with loses clay bricks.

The architectural surface is lined with cracks. The plaster layers are detached from the adobe masonry, being at high risk to falling off. Partially, the paint layers show deterioration phenomena like flaking and powdering. Dust covers all exposed surfaces.

An intervention is necessary to halt active deterioration and preserve the original plaster and wall painting.

The following steps of emergency measures were done in the field schools of 2012, 2014 and 2018. The architectural surface was dry cleaned by using soft brushes. For temporary protection fragile parts of the wall paintings were faced with Japanese paper. The many fallen-off plaster fragments were secured, documented and stored separately.

The main goal was to stabilize the paint layer supporting plasters. The structurally consolidation of the adobe masonry surface provided a solid structure for the treatments to follow. In addition, lost joints were infilled. The plaster layers were stabilized by edging detached fragments. The conservation mortar contains cellulose-ether as binder and is reversible. To improve the bondage between coat and support, voids were filled by grout injections based on a silica binder. Softened and fragile paint layers were structurally consolidated and re-stabilized.

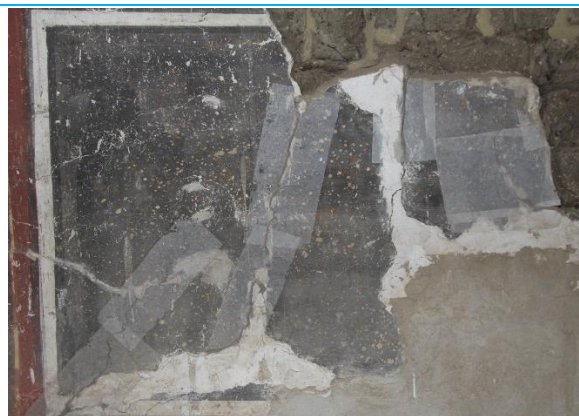
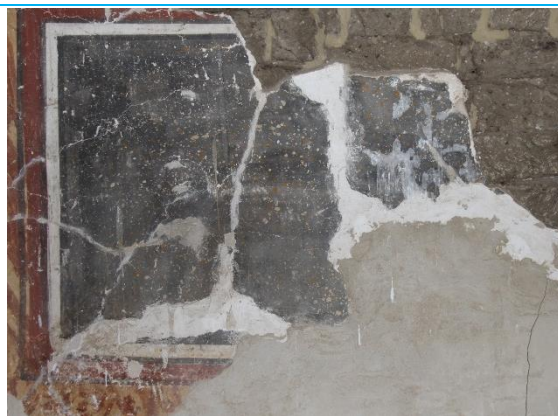
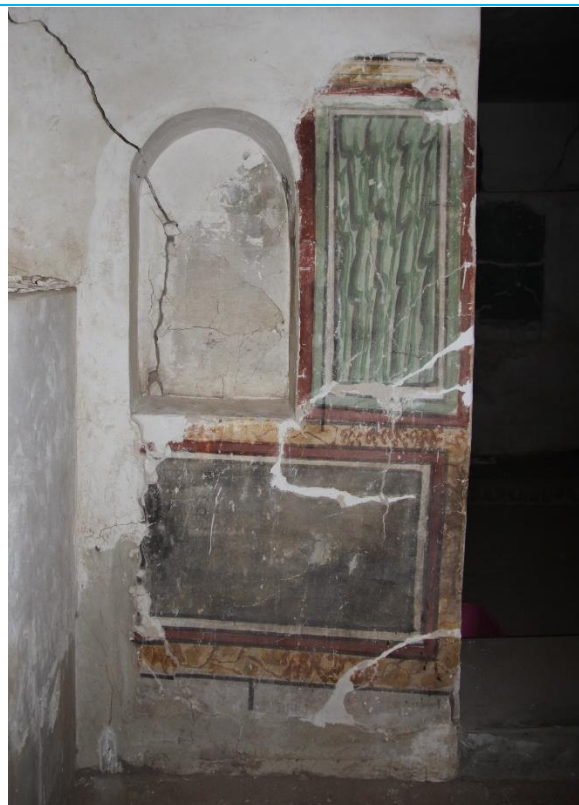
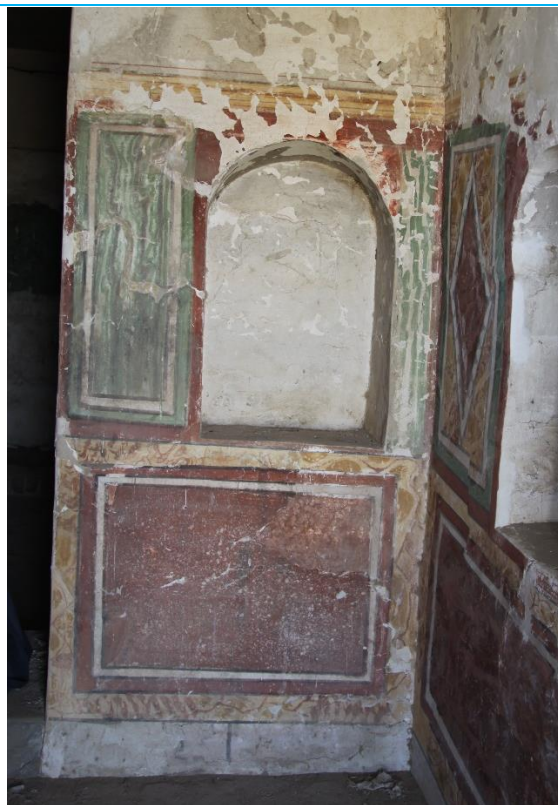
Emergency measures have been carried out to prevent further decay. The tomb house is protected by a lockable door. For the future it would be desirable to establish a maintenance and monitoring programme.

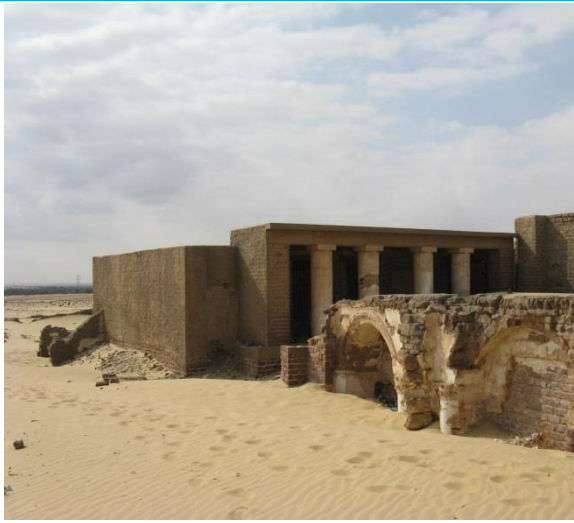
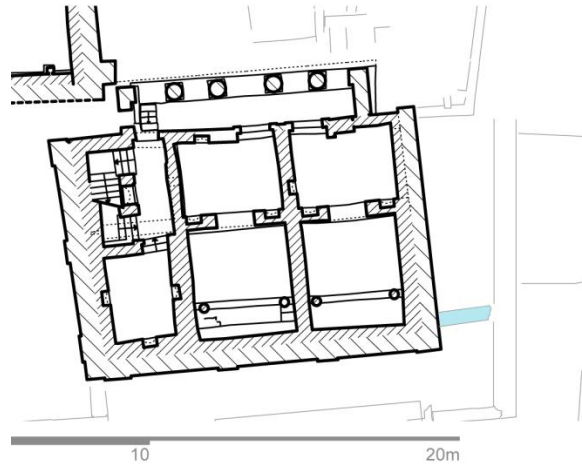
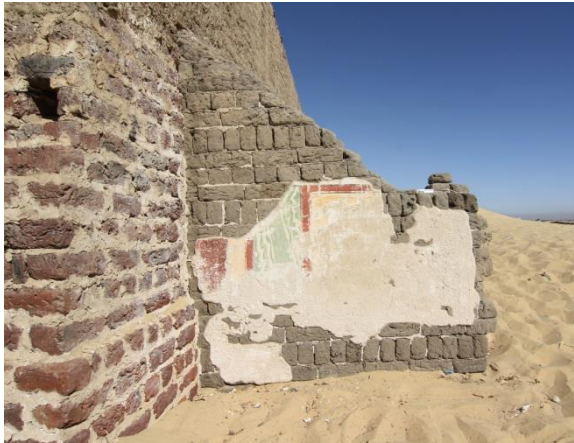
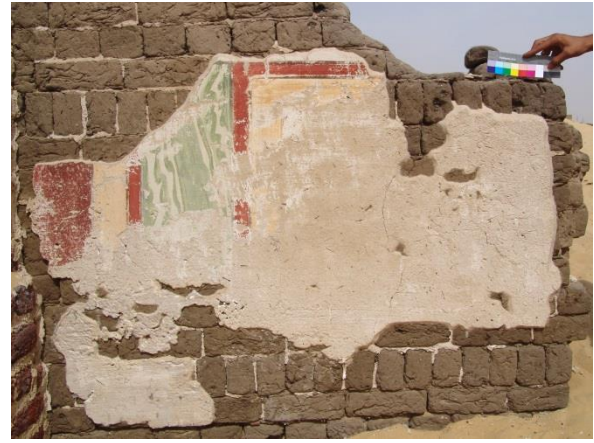
The wall fragment is half buried in the sand. Where visible, the adobe masonry shows a structurally destabilised and sanding surface. The deterioration had reduced the joint mortars. The architectural surface is lined with cracks. Additionally the plaster layers are detached from the adobe masonry, being in high risk to falling off. The paint layers are heavily reduced. Partially, the paint layers show deterioration phenomena as powdering.

An intervention is necessary to halt active deterioration and preserve the original plaster and wall painting.

Treatment	
<p>The following steps of emergency measures were done in the field schools of 2012, 2014 and 2015. The architectural surface of the facade was dry cleaned by using soft brushes. For temporary protection fragile parts of the plaster layer were faced with Japanese paper and cellulose-ether glue.</p> <p>The main goal was to stabilize the painted plaster insitu. The structurally consolidation of the adobe masonry surface next to the preserved plasters provided a solid structure for the treatments to follow. Additionally, lost joints were infilled. The plaster layers were stabilized by edging detached fragments. The conservation mortar contains cellulose-ether as binder and is reversible. To improve the bondage between coat and support, voids were filled by grout injections based on a cellulose-ether binder. Due to the outdoor situation all conservation plasters were finally structurally strengthened with a silica binder.</p> <p>To learn about details of all conservation steps and materials please refer to the link “treatment” to be found on the front page introduction.</p>

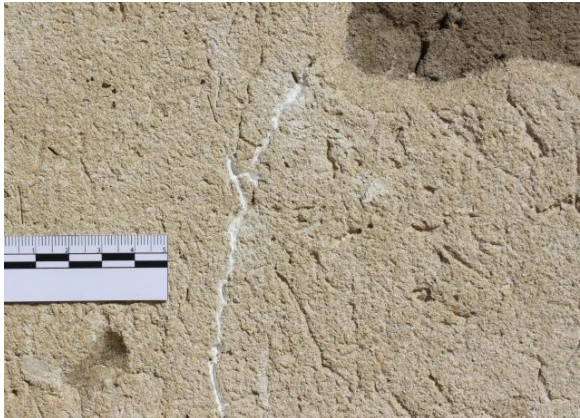
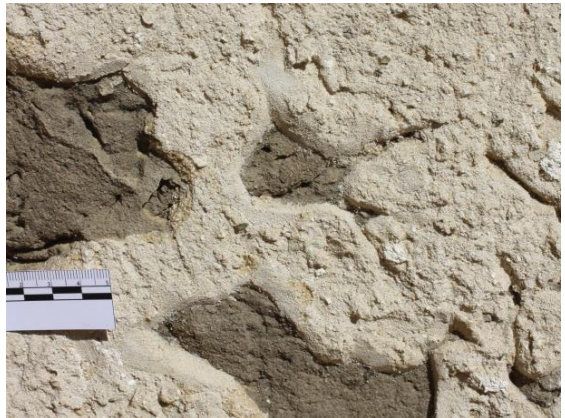
Condition after treatment	
<p>Emergency measures have been carried out to prevent further decay. The wall fragment is exposed to the elements and human action. In this respect, it would be desirable to continue the emergency measures and to establish maintenance and monitoring programme for the future.</p>	
Status: November 2015
