Tomb no. GB 16 (Gabra no. M 06/SS) anteroom

Condition before treatment

Treatment

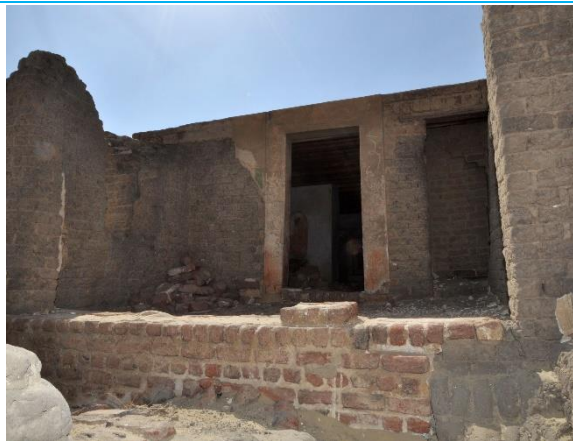
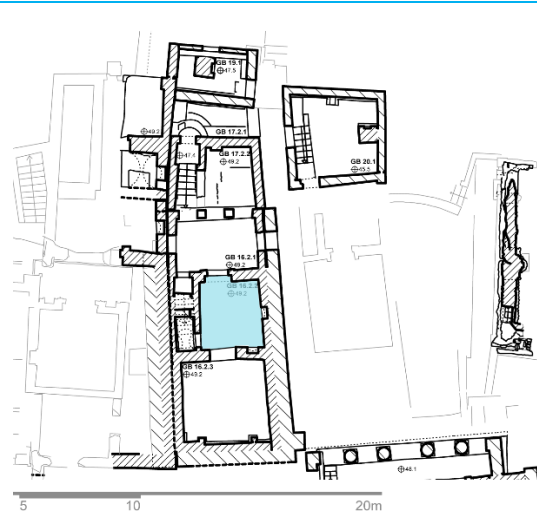
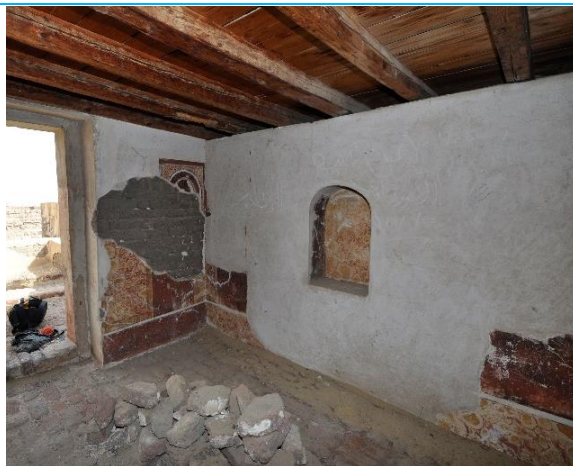
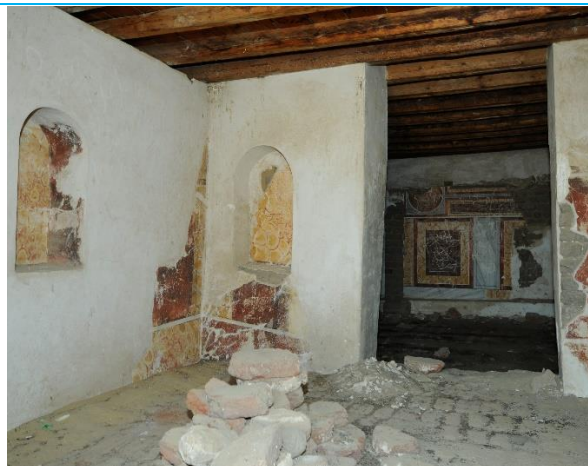
A multi-storey tomb house made of adobe masonry. Today three rooms on the second floor are accessible via a staircase and through a portico.

The inside walls are plastered with lime mortar. The floor as well was covered with a thin plaster layer painted with red colour. Only near the walls survived fragments of this red floor.

On the walls, the plaster layer was whitewashed in the upper areas. Along the lower half of the walls a second thin plaster layer was applied and decorated with imitations of stone incrustations. The polychrome paintings were carried out directly on the smooth plaster surface.

The lost areas of the original plaster have been closed parallel to the reconstruction of the roof. The repair phase with white plaster was left unpainted.

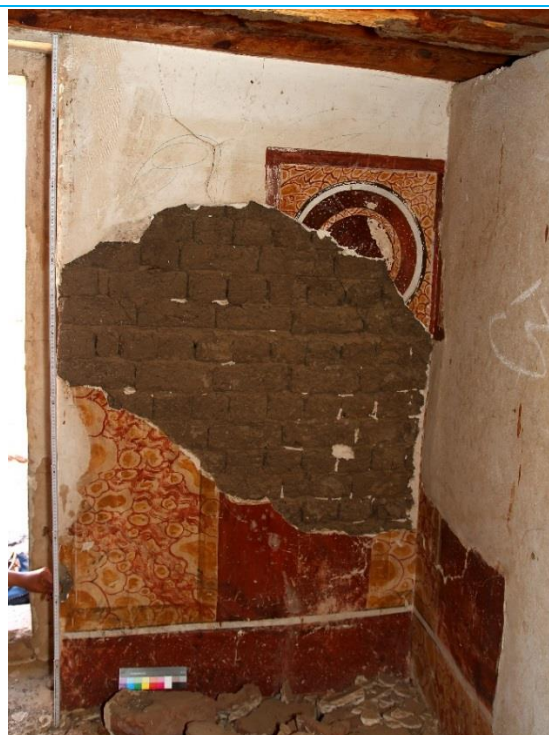
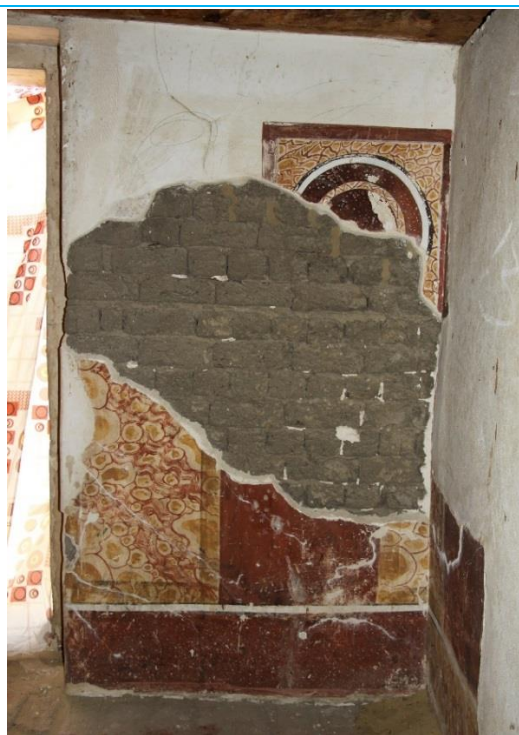
The plaster layers are partially lost and expose the sun-dried clay brick masonry (adobe). Collapsed plaster fragments could be found on the floor. Where visible, the adobe masonry shows a structurally destabilised and sanding surface. Parts of the joints are lost.

There is a layer of dust on everything and a thick layer of bat excrements on the floor. The architectural surface is lined with cracks. Additionally, the plaster layers are detached from the adobe masonry, being endangered to falling off. In particular, the southern-eastern corner is especially fragile. The paint layers are reduced, but the remaining colours are stable.

An intervention is necessary to halt active deterioration and preserve the original plaster and wall painting.

The following steps of emergency measures were done in the field schools of 2014, 2015 and 2018. The anteroom was cleaned. For temporary protection fragile parts of the wall painting were faced with Japanese paper. The many fallen-off plaster fragments were secured, documented and stored separately.

The main goal was to stabilize the paint layer supporting plaster. The consolidation of the adobe masonry surface provided a solid structure for the treatments to follow. In addition lost joints were infilled. The plaster layers were stabilized by edging detached fragments. The conservation mortar contains cellulose-ether as binder and is reversible. To improve the connection between masonry and plaster, voids have been filled by grout injections based on a silica binder.

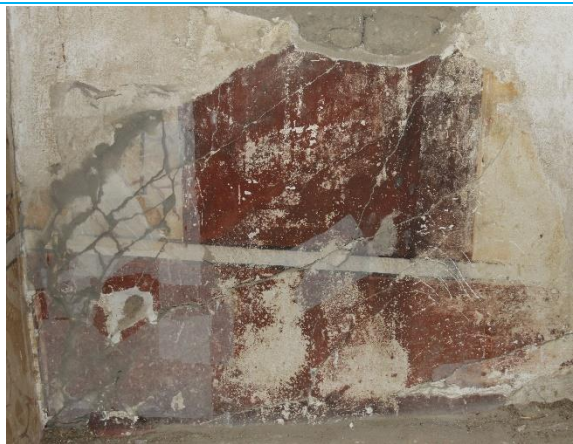
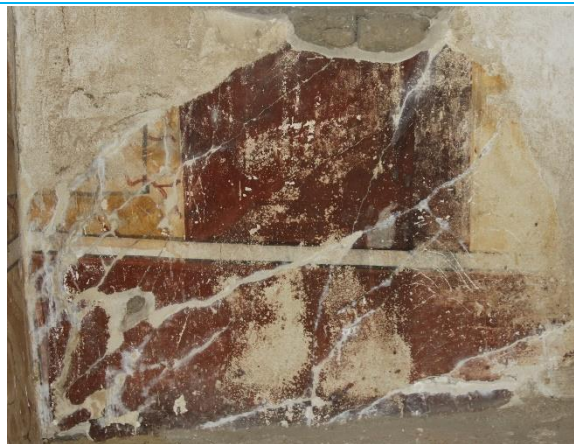
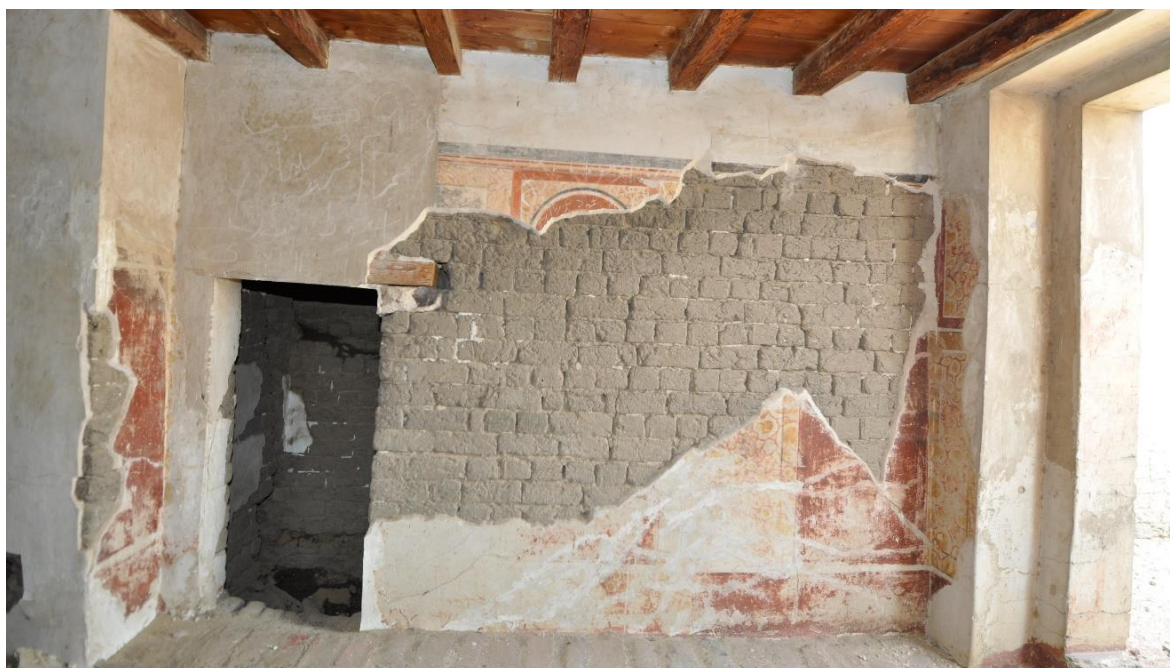
Emergency measures have been carried out to prevent further decay. Near by the walls the fragments of the lime plaster floor have been covered by sand for protection.

The tomb house is open, and the wall paintings are exposed to the elements and human action. In this respect, it would be desirable to establish maintenance and monitoring programme for the future.
