## Tomb no. GB 20 (Hermokrates)

### Description of the interior design

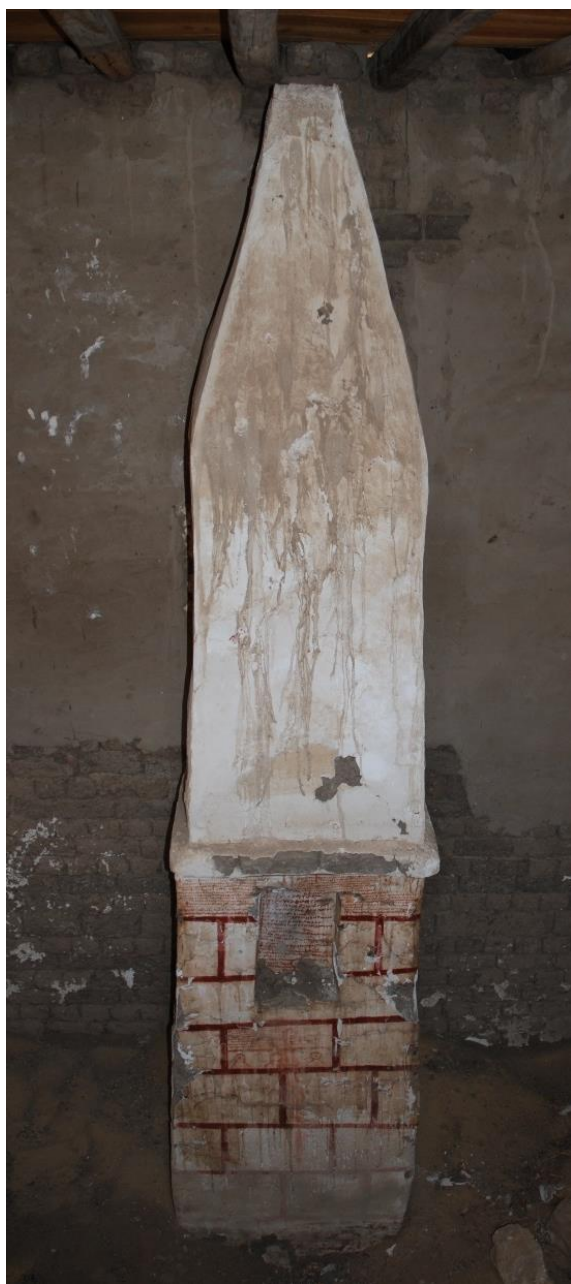
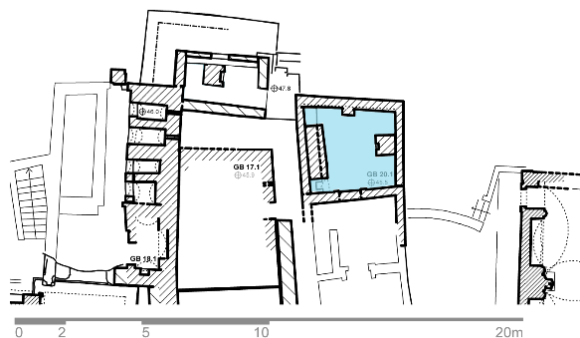
There is a layer of dust on everything. Additionally, traces of mud runners dirty the stele. The wax or paraffin cover became partly opaque and grey. So the decorations are no longer completely visible.

The plaster layer is partially lost and exposes the adobe masonry. Where visible the sun dried clay bricks show a sanding surface. The plaster layers are widely detached from the adobe masonry, and show fine lined cracks.

Partially the paint layers are flaking and rolls off the underground like paper, due to the very thick and uneven wax or paraffin cover. The surface shows an ongoing deterioration and the decoration is at risk.

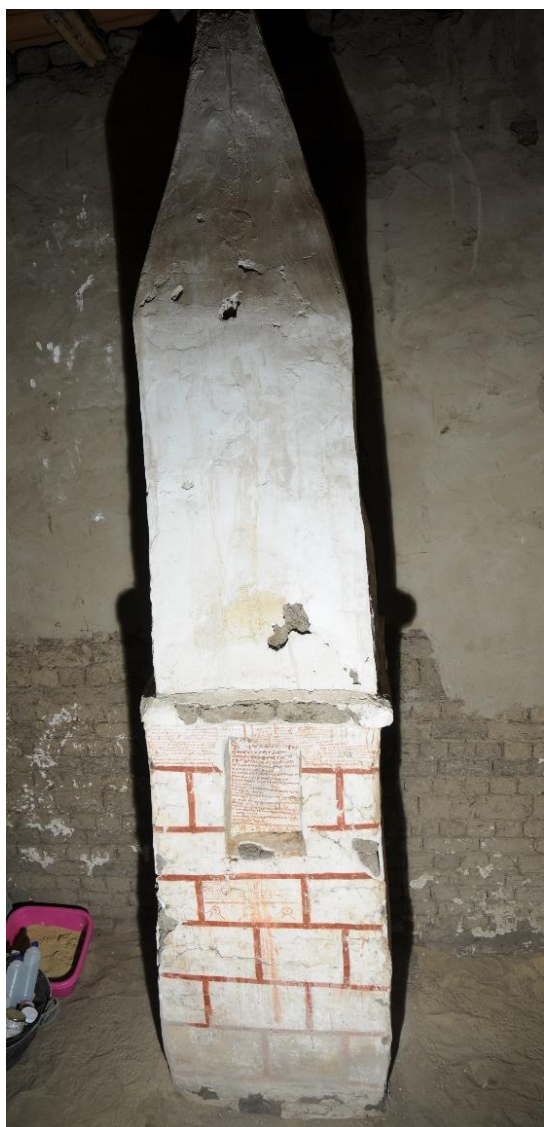
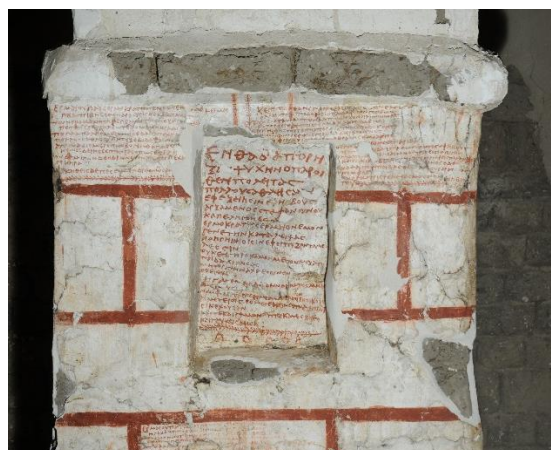
Emergency measures have been carried out to prevent further decay. The tomb house is closed by a sealed door. In addition the tomb was provided with a new window covered with netting wire to prevent birds from nesting in the shelter house. The mesh cover of the window should be checked regularly.

The following steps of emergency measures were done 2009 and 2010 by the conservator Alexandra Winkels. The architectural surface was dry cleaned by soft brushes and wet cleaned with iso-propanol. For temporary protection fragile parts of the plaster layer were faced with Japanese paper and a cellulose-ether. The residues of the wax or paraffin cover, spilled over the surface during a former restoration treatment, could be reduced and the flaking paint layer simultaneously reattached. The reduction was done by using a special conservation-iron to and Japanese tissue as interlayer to melt and remove the waxy coat.

The exposed adobe masonry surface was structurally strengthened with a silica binder. The plaster layers were stabilized by edging detached fragments with a lime mortar. To improve the bondage between coat and support, voids have been filled by grout injections based on a dispersed lime binder. Gaps in the plaster were closed with lime mortar.
