Tomb no. GB 21 (Gabra no. M 11/SS)

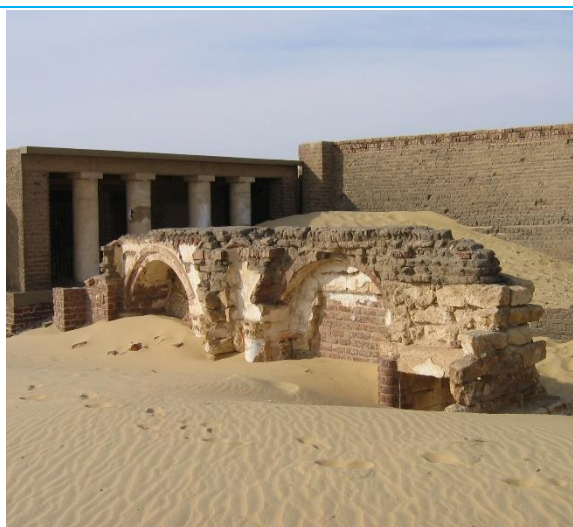
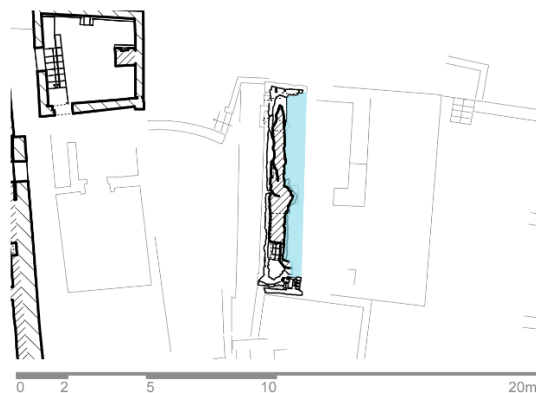
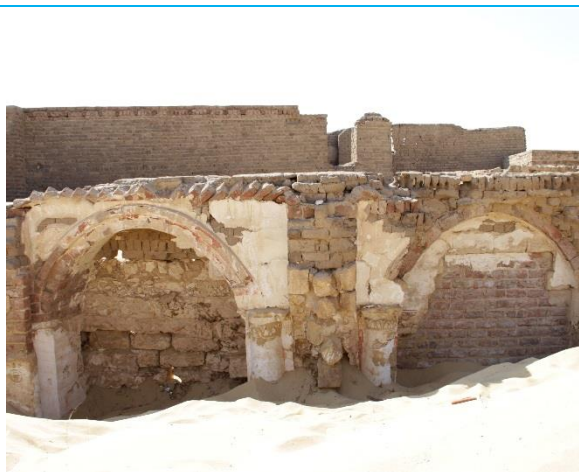
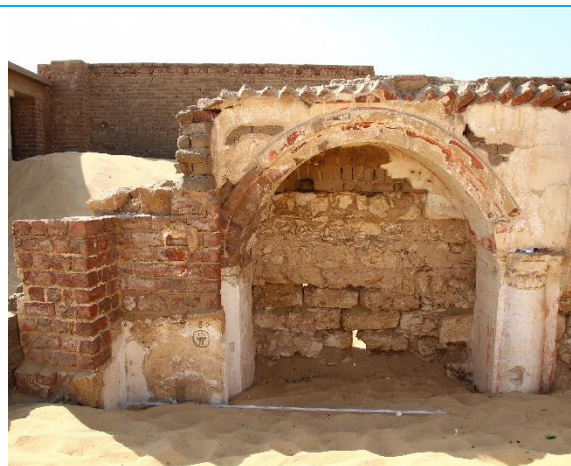
The wall fragment is half buried in the sand. Where visible, the adobe masonry shows a structurally destabilised and sanding surface. The deterioration had reduced the joint mortars. The plaster layers are detached from the adobe masonry. A lot of fragments can be found in the sand. The paint layers are heavily reduced.

An intervention is necessary to halt deterioration and preserve the original plaster and wall painting.

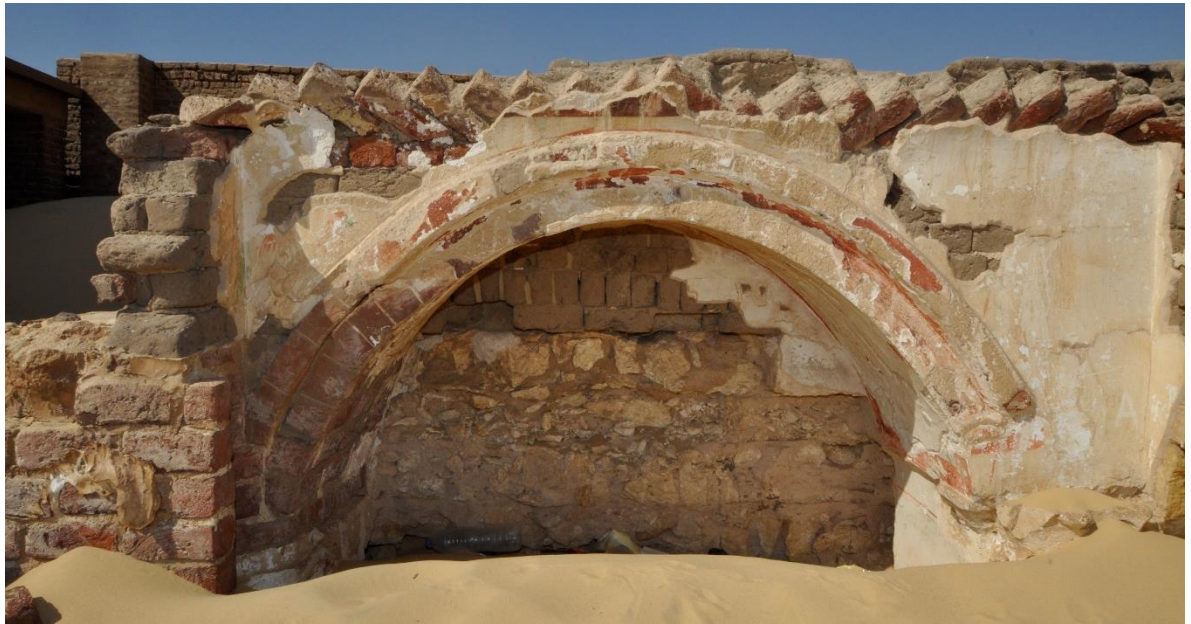
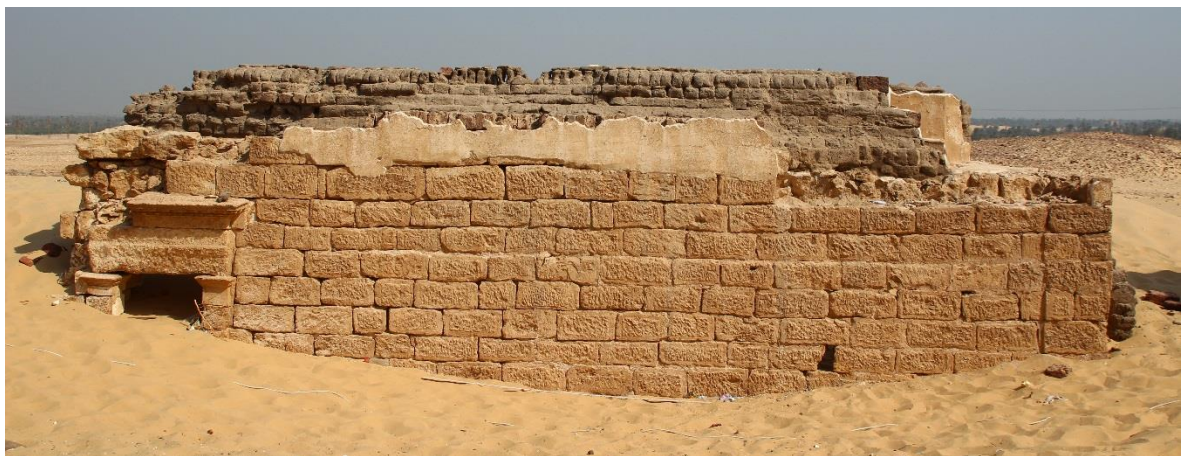
Emergency measures have been carried out to prevent further decay. The wall fragment is exposed to the elements and human action. In this respect, it would be desirable to establish a maintenance and monitoring programme for the future.
