Tomb no. GB 24 (Gabra no. M 09/SE) portico

Description of the interior design

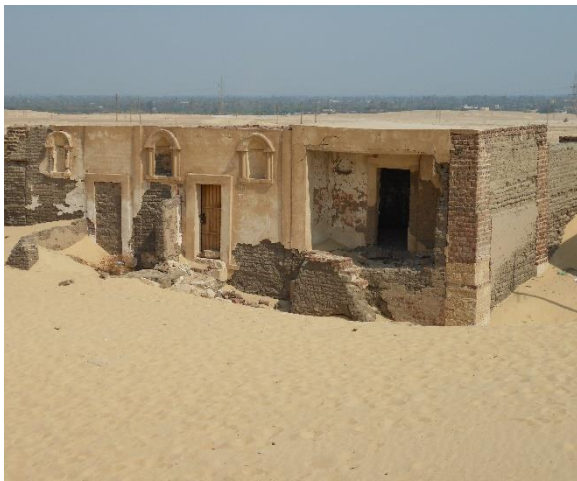
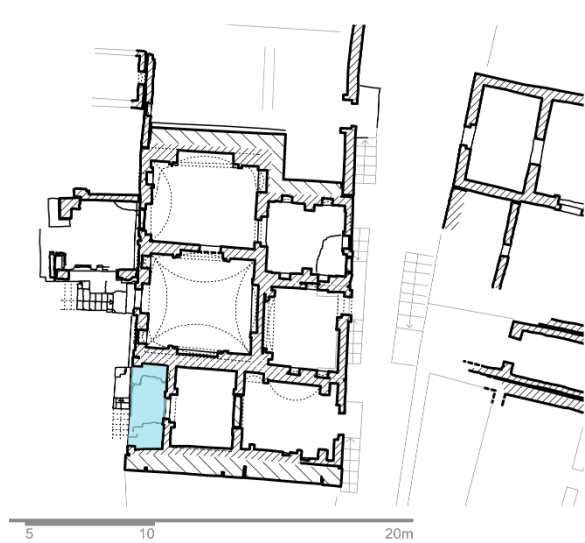
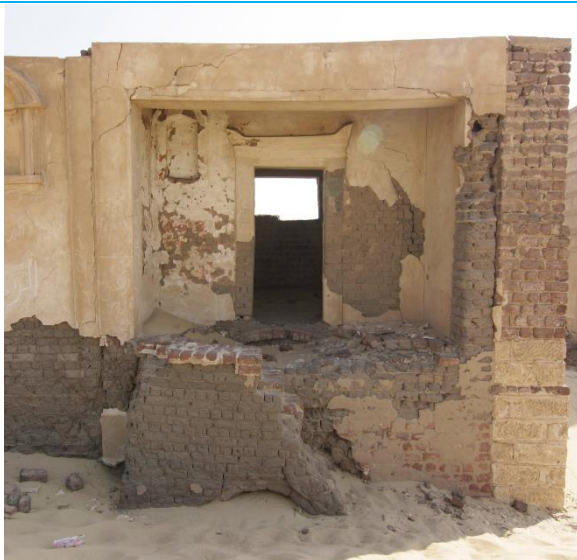
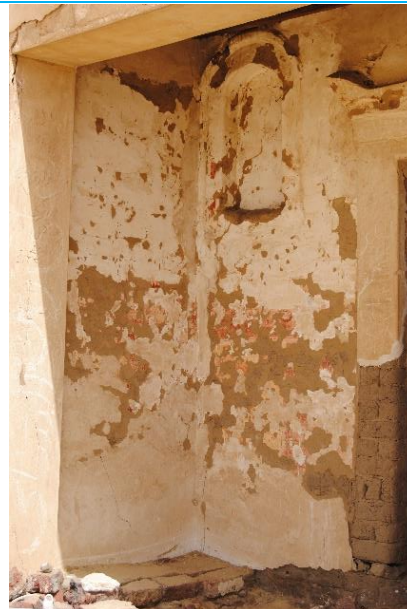
A western orientated portico serves as an entrance for a two-room tomb house on the second floor. The stairway in front is lost. The tomb house was built of adobe masonry coated with a layer of clay plaster. A thick whitewash on the top served as a base for wall paintings. The walls had been decorated with yellow and red colours, probably a red base with plants and fruits garlands above, like the decoration inside of this tomb house.

Big parts of the original decoration are lost, except of the architectural surface of the northern-eastern corner. The lost areas of the original plaster have been closed parallel to the reconstruction of the roof. The repair phase with a white plaster was left unpainted. Partially the repair plaster is overlapping the historic painted surface. Today, the repair plaster partially got lost as well.

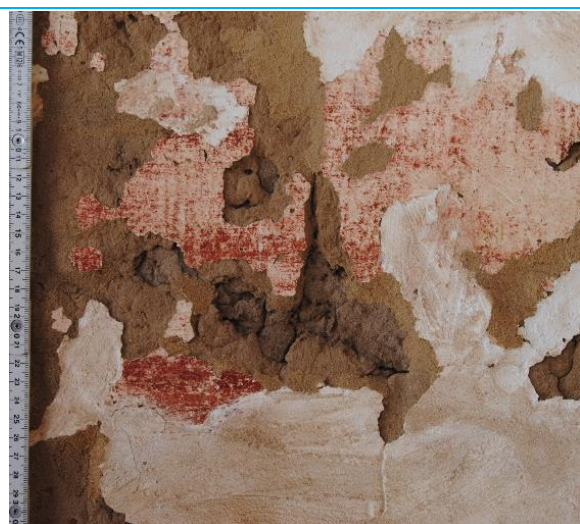
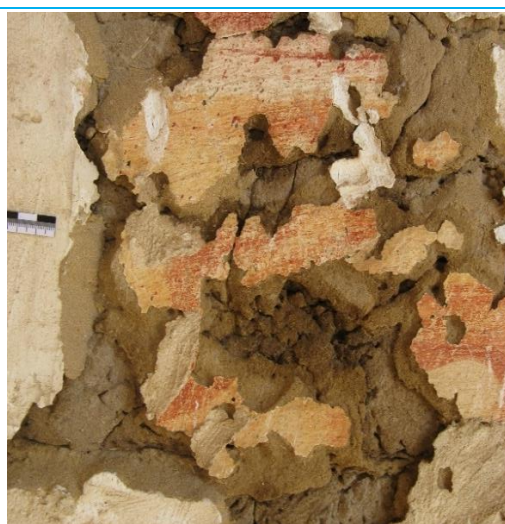
The paint layers are heavily reduced, but the remaining colours are stable. The plaster layers got partially and inhomogeneously lost, exposing the supporting adobe structures through many little gaps. Where visible, the adobe masonry and plasters shows a strong structural instability, by detachment from the support and sanding surfaces. The architectural surface looks like washed out, apparently caused by erosion with wind and sand. As a result, the fragile whitewash layers are detached from the adobe support and are in danger to falling off.

An intervention is necessary to halt active deterioration and preserve the original plaster and wall painting.

The following steps of emergency measures were done in the field schools of 2014, 2015 and 2018. The architectural surface was dry cleaned by soft brushes. For temporary protection fragile parts of the painted layers were faced with Japanese paper and cellulose-ether glue.

The main goal was to stabilize the support and with it the paintings. The consolidation of the adobe masonry surface provided a solid structure for the treatments to follow. In addition, small gaps in the clay plaster were infilled. The clay plaster and fragile whitewash layer were stabilized by edging detached fragments with conservation mortar. The conservation mortar is based on a cellulose-ether binder mixed with sand and a little amount of clay. To improve the bondage between coat and support, small voids were filled by grout injections based on a silica binder. Due to the outdoor situation the conservation mortars were finally structurally strengthened with a silica binder.

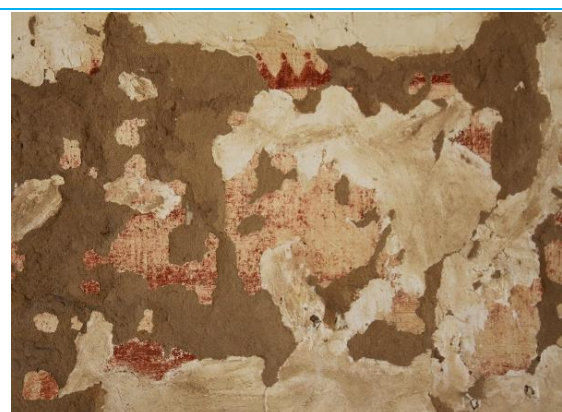
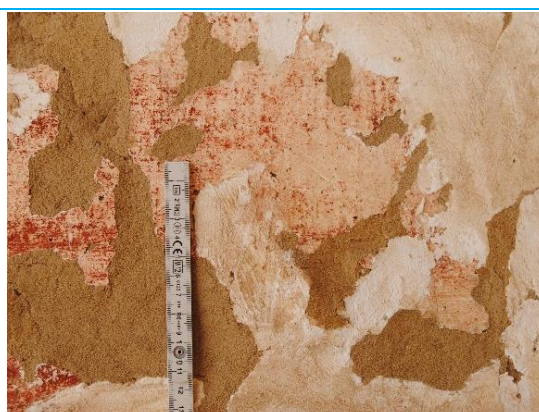
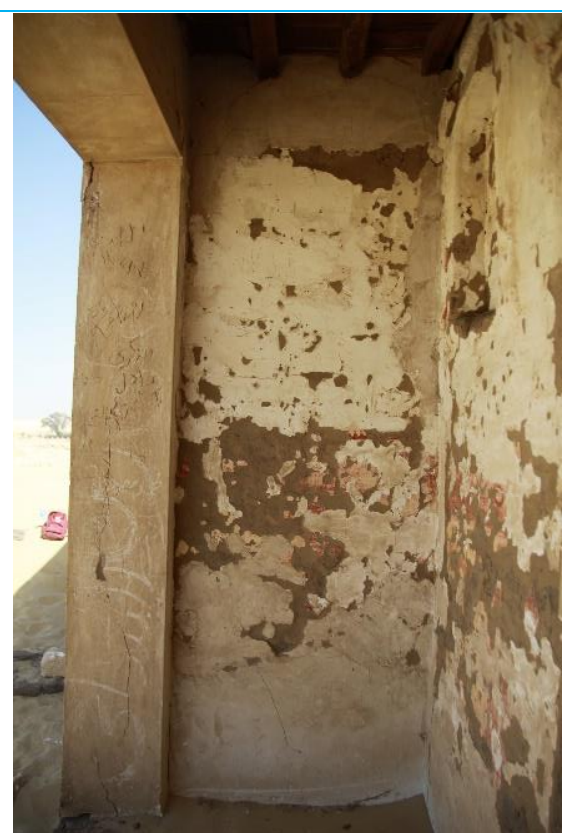
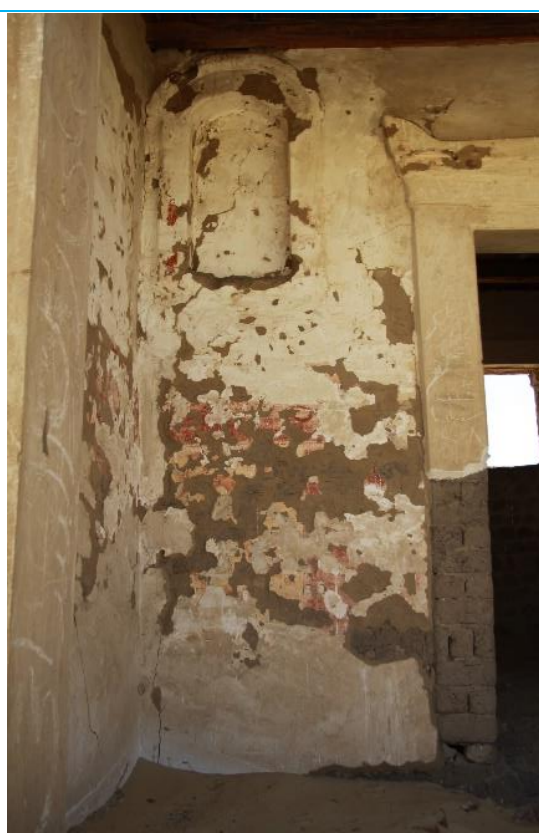
Emergency measures have been carried out to prevent further decay. The wall fragments are exposed to the elements and human action. In this respect, it would be desirable to establish a maintenance and monitoring programme for the future.

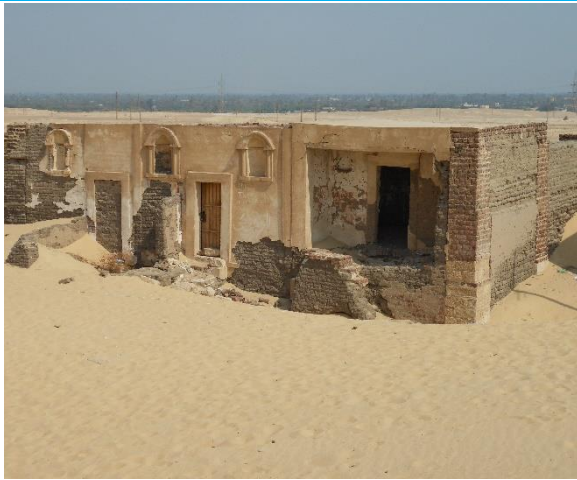
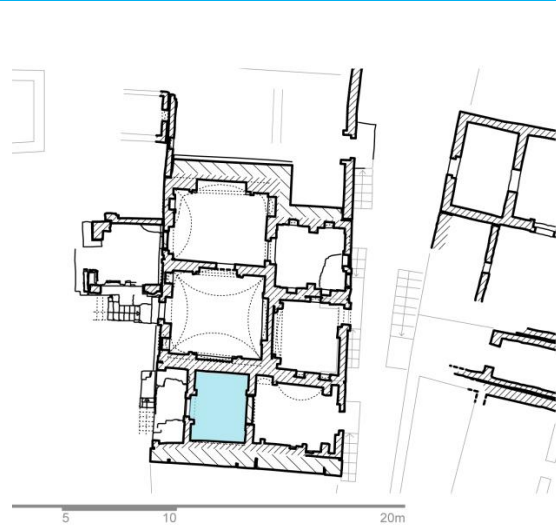
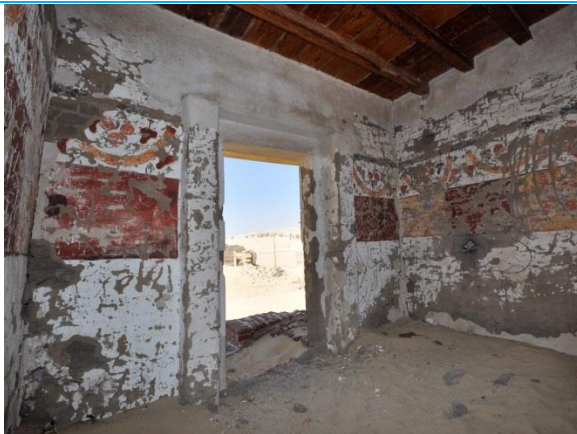
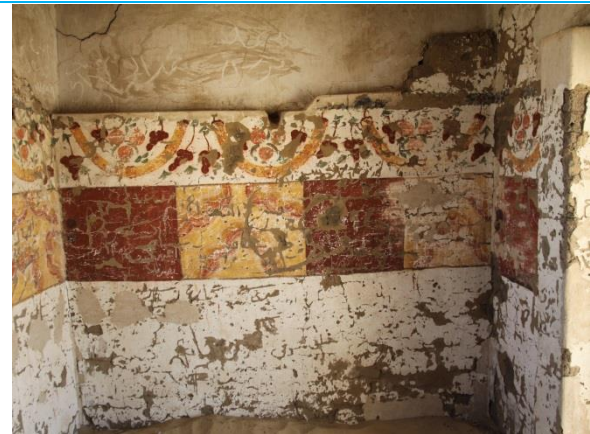
A two-room tomb house with a portico on the second floor. It was built of adobe masonry coated with clay plaster. A thick whitewash was applied on the top plaster layer that carries the wall paintings. The walls are decorated with a yellow and red coloured frieze and fruits and leaves garlands above.

The lost areas of the original plaster in the upper parts of the walls have been closed parallel to the reconstruction of the roof. The repair phase with white plaster was left unpainted.

The architectural surface of the following main room and the main parts of its walls are lost. The door from anteroom to main room is half closed by sun-dried clay bricks.

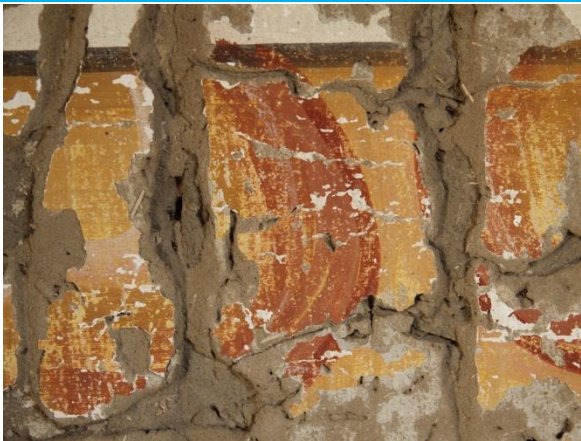
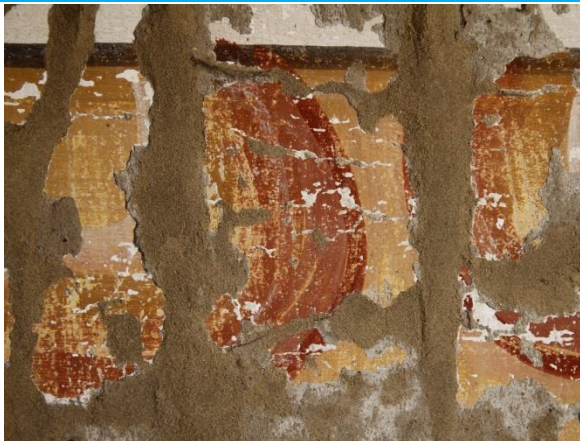
Condition before treatment	
<p>The paint layers are heavily reduced, but the remaining colours are stable. The plaster layers are partially and inhomogeneously lost, exposing the supporting adobe structures through many little gaps. The architectural surface is damaged by many scratch marks and graffitis. Additionally, traces of animals destroyed part of the adobe structure. The fragile whitewash layers are detached from the adobe support, being endangered to falling off.</p> <p>An intervention is necessary to halt active deterioration and preserve the original plaster and wall painting.</p>	
Treatment	
<p>The following steps of emergency measures were done in the field school 2018. The architectural surface was dry cleaned by using soft brushes. For temporary protection fragile parts of the wall painting were faced with Japanese paper and cellulose-ether glue.</p> <p>The main goal was to stabilize the white wash layer as base for the paint layers. The fragile whitewash layer and the clay plaster layers were stabilized by edging detached fragments. In addition, small gaps in the clay plaster were infilled. The conservation mortar contains cellulose-ether as binder and is reversible.</p> <p>To learn about details of all conservation steps and materials please refer to the link “treatment” to be found on the front-page introduction.</p>

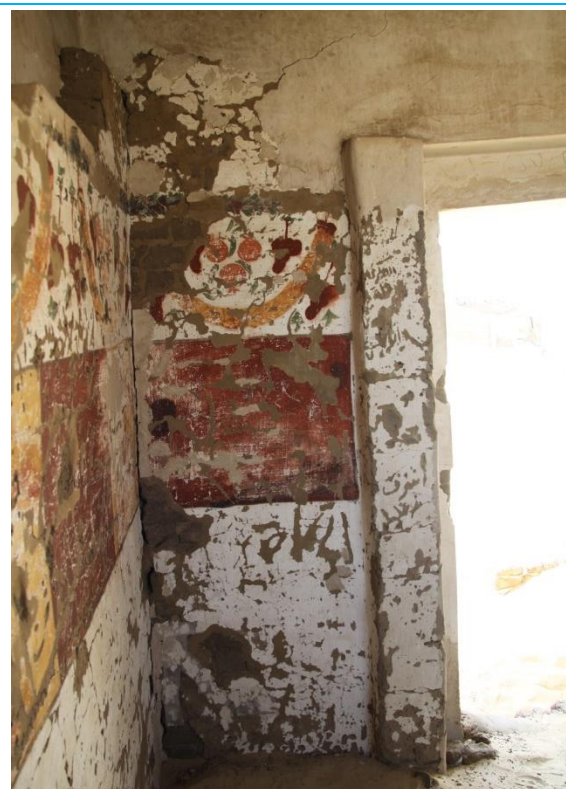
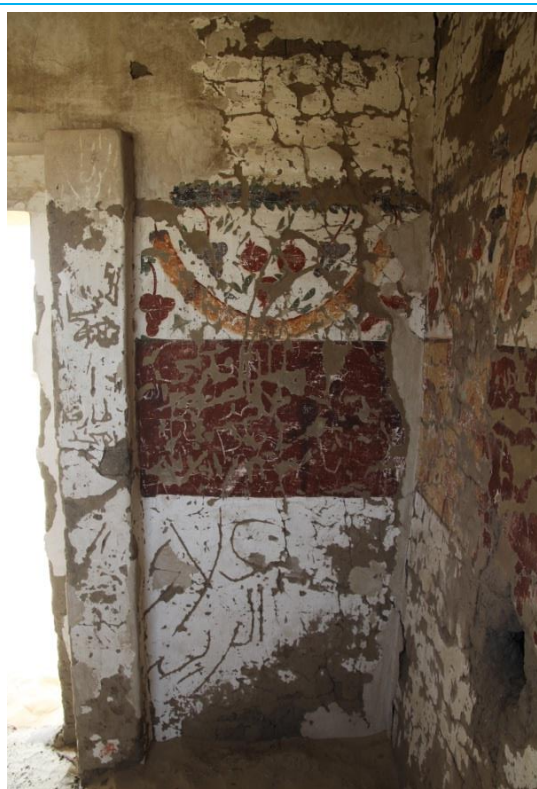
The wall paintings are exposed to the elements and human action. The most vulnerable areas of the artwork could be stabilized. Fragile parts of the wall painting, which could not be consolidated in the working campaigns, were faced with Japanese paper and cellulose-ether to keep in place. Further treatment is essential to guarantee long-term conservation.
