## Tomb no. GB 25 (Gabra no. M 09a/SE) inside

### Description of the interior design

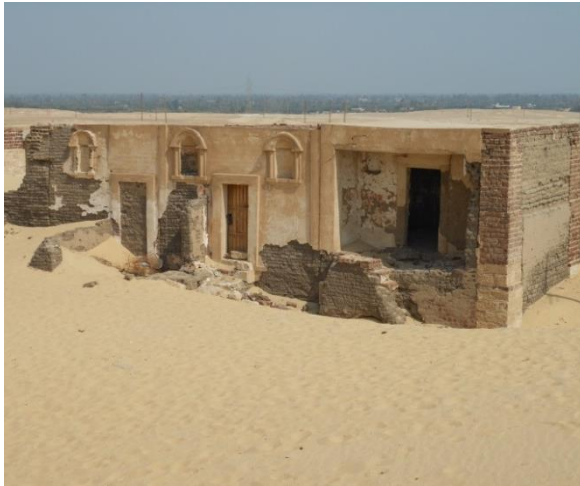
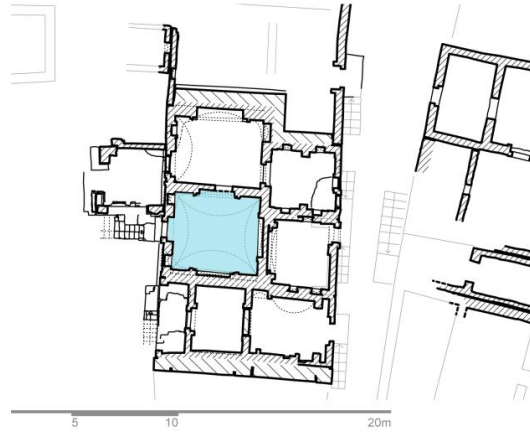
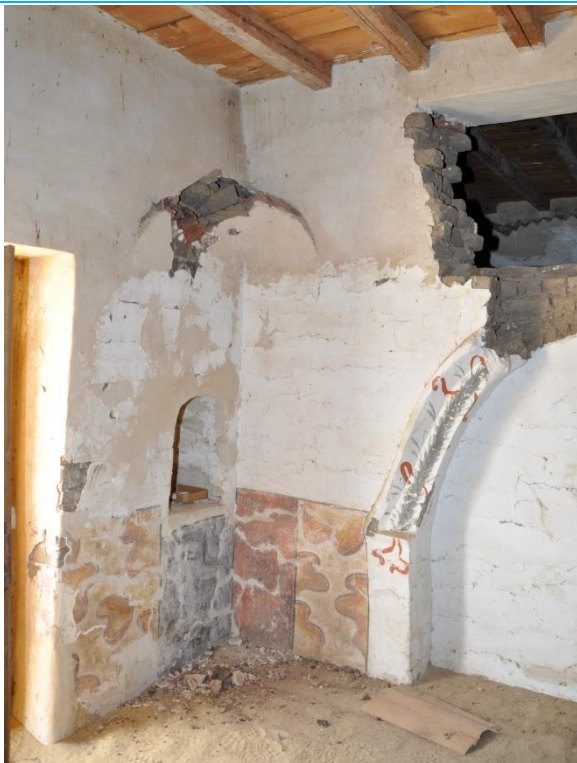
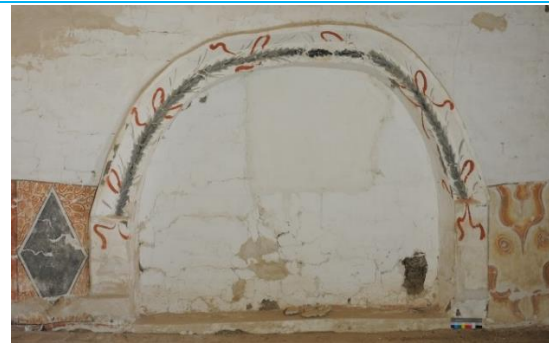
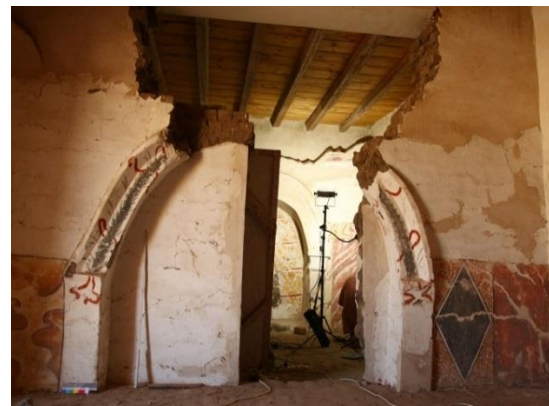
A one room tomb house on the second floor, which today is today connected with the neighbour tomb houses. The decoration is dominated by two large arched niches located opposite one another on the northern and the southern walls. These niches are framed with a garland of leaves and loops and the base decorated with stone imitations.

Inside the adobe masonry is overall coated with one layer of lime plaster. In areas of painted decoration a second thin layer was plastered. The polychrome paintings were carried out directly on the smooth plaster surface. In the upper monochrome white areas a whitewash was applied.

The lost areas of the original plaster in the upper part of the walls have been closed parallel to the reconstruction of the roof. The roof was reconstructed flat, not as a dome.

<b>Condition before treatment</b>	
<p>The architectural surface is lined with cracks. Additionally the plaster layers are detached from the adobe masonry, being endangered to falling off. Small parts of the painted plaster are lost.</p> <p>The paint layers are reduced, but the remaining colours are stable. There is a layer of dust on the whole structure.</p> <p>An intervention is necessary to halt active deterioration and preserve the original plaster and wall painting.</p>	
<b>Treatment</b>	
<p>The following steps of emergency measures were done in the field schools of 2014. The surfaces of the large niche in the southern wall were cleaned. Fragile edges of the plaster layers were structurally consolidated. For temporary protection fragile parts of the wall painting were faced with Japanese paper.</p> <p>The work had to be interrupted because the floor of this room is not safely accessible.</p>

<b>Condition after treatment</b>	
<p>Fragile parts of the wall painting were faced with Japanese paper and cellulose-ether glue. Further treatment is essential to guarantee long-term conservation.</p> <p>In June 2018 plaster layers in the northern-eastern corner were damaged. The broken edges of these damaged parts in the white plaster could be secured directly in October 2018. On the long term it would be desirable to continue the emergency measures and to establish maintenance and monitoring programme for the future.</p>	
<b>Status: October 2018</b>
