Tomb no. GB 33 (Gabra no. M 20/SE) anteroom

Tomb no. GB 33 (Gabra no. M 20/SE) main room

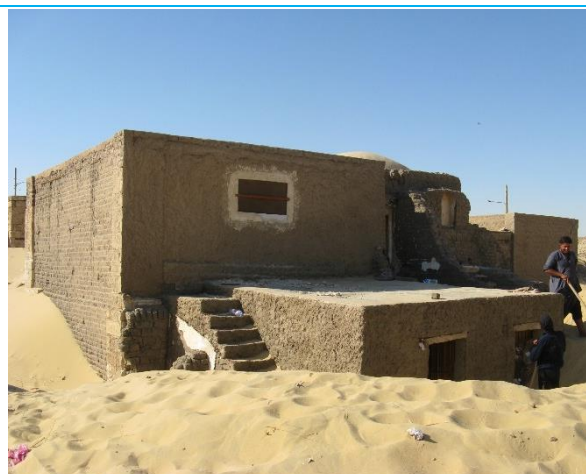
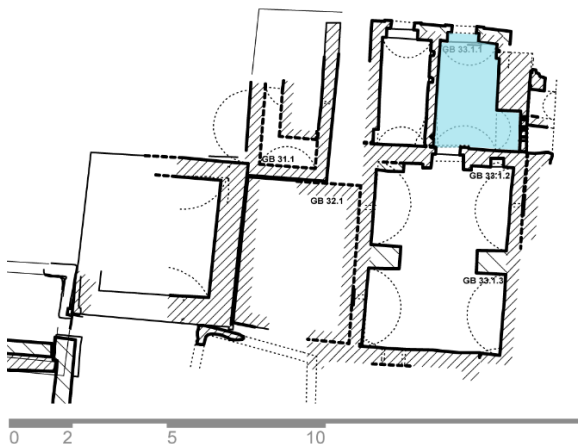
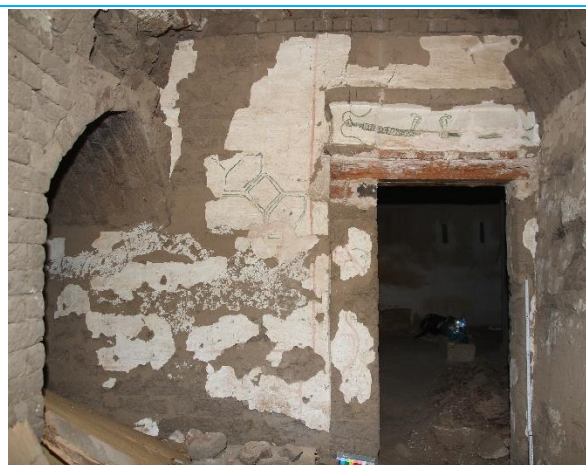
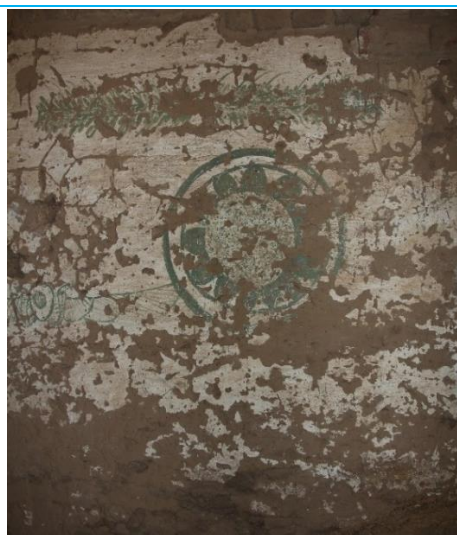
On the ground floor this tomb house has an anteroom and a main room with singular paintings in Egyptian style with figures and animals. The anteroom is decorated with green drawings on a white primer.

The tomb house is built of adobe masonry. On the ground floor the adobe masonry is coated with a layer of clay plaster. All interior walls have a finish with a thick layer of lime wash topped with a thin layer of whitewash that carries partially wall paintings.

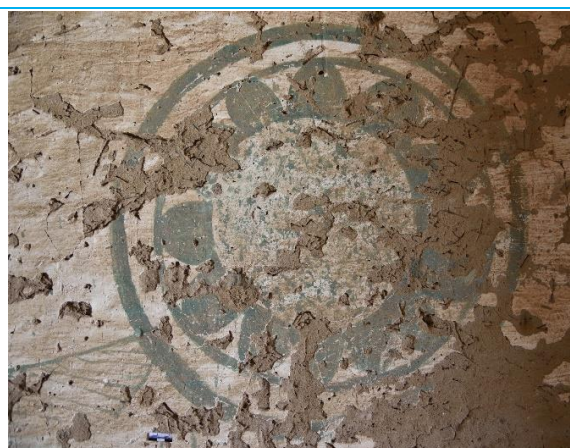
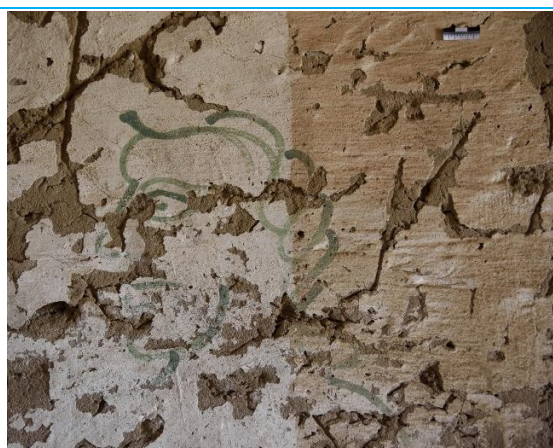
Condition before treatment

The wash layers supporting the paintings are partially lost and expose the adobe structures underneath. Additionally, the clay plaster is partially and inhomogeneously lost. Collapsed plaster and painting fragments could be found on the floor. Where visible, the adobe masonry shows a structurally destabilised and sanding surface.

The architectural surface is lined with cracks. The fragile wash layers and the clay plaster layers are detached from the adobe masonry, being at high risk to falling off.

The paint layers are heavily reduced. Partially the paintings shows deterioration phenomena's like flaking and powdering. Dust covers all exposed surfaces.

An intervention is necessary to halt active deterioration and preserve the wall paintings.

The following steps of emergency measures were done in the field schools of 2010 and 2015. The architectural surface was partially dry cleaned by using soft brushes. For temporary protection fragile parts of the wall painting were faced with Japanese paper. The fallen-off plaster fragments were secured, documented and stored separately.

The main goal was to stabilize the plasters with paint layers. The structurally consolidation of the adobe structure surface next to and underneath the paintings provided a solid structure for the treatments to follow. The fragile lime wash layer and the clay plaster were stabilized by edging detached fragments with conservation mortar. Little gaps were infilled. To improve the bondage between coat and support, fine voids were filled by grout injections. All conservation mortars contain cellulose-ether as binder and are reversible. Softened and fragile paint layers were structurally consolidated and re-stabilized.

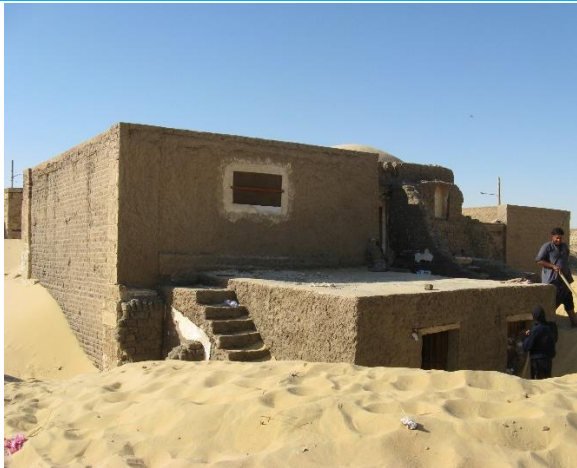
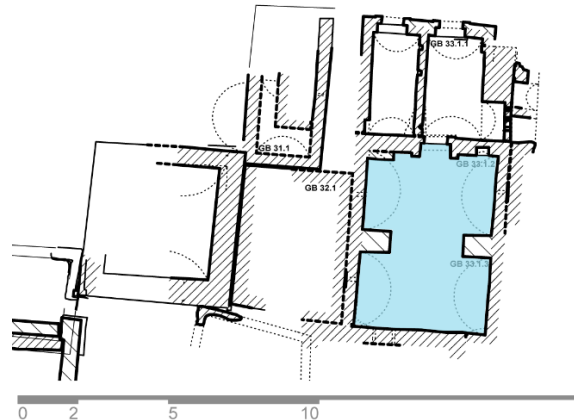
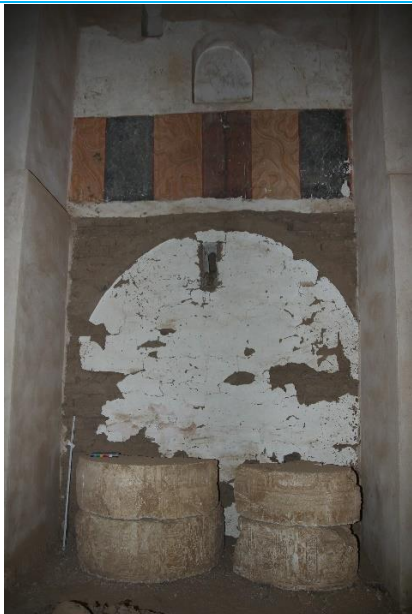
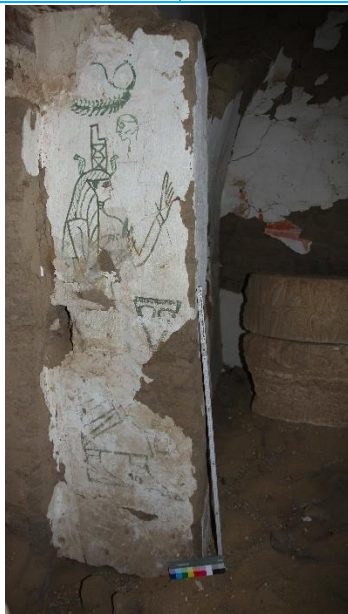
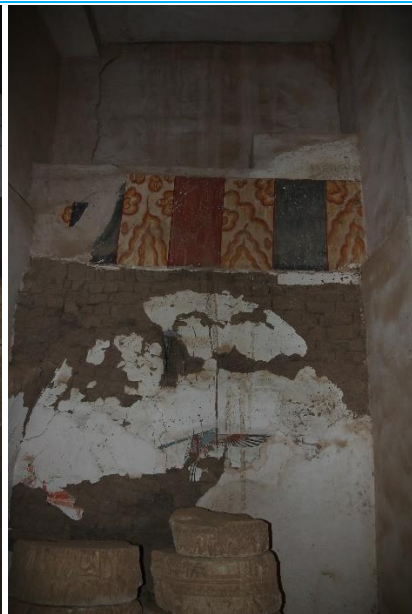
On the ground floor this tomb house has an anteroom and a main room with singular paintings in Egyptian style with figures and animals. On the second floor it has a main room with roman style wall paintings with imitations of stone incrustations and floral festoons. The original vault ceiling of the ground floor is completely lost, hence the interior decorations of both floors are visible in one main room.

The tomb house is built of adobe masonry. On the ground floor the adobe masonry is coated with a layer of clay plaster. On top of this a thick lime wash was applied and additionally a thin whitewash. The whitewash serves as a base for partial paintings.

On the second floor the adobe masonry is coated with a layer of lime plaster. All interior walls have a finish of a whitewash serving as a base for the wall paintings.

In the main room the upper parts of the walls lost areas of the original plaster have been closed parallel to the reconstruction of the roof of the second floor. The white repair phase plaster was left unpainted.

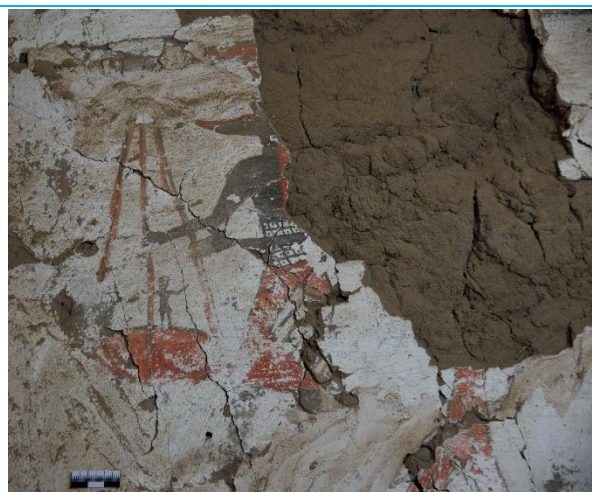
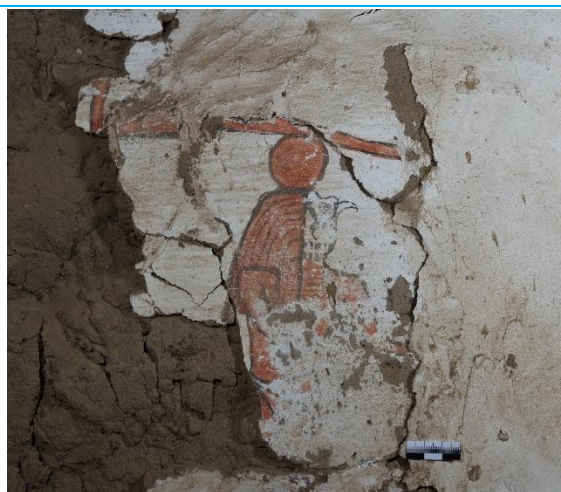
Condition before treatment

So far, the walls on the ground floor have been investigated. The wash layers supporting the paintings are partially lost and expose the adobe structures underneath. Additionally, the clay plaster is partially and inhomogeneously lost. Collapsed plaster and painting fragments could be found on the floor. Where visible, the adobe masonry shows a structurally destabilised and sanding surface.

The architectural surface is lined with cracks. The fragile clay and lime wash layers are detached from the adobe masonry, being at high risk to falling off.

The paint layers are heavily reduced. Partially the paint layers shows deterioration phenomena's like flaking and powdering. Dust covers all exposed surfaces.

An intervention is necessary to halt active deterioration and preserve the original plaster and wall paintings.

The following steps of emergency measures were done in the field schools of 2010 and 2015. The architectural surface was partially dry cleaned by using soft brushes. For temporary protection fragile parts of the wall painting were faced with Japanese paper. The fallen-off plaster fragments were secured, documented and stored separately.

The main goal was to stabilize the white wash layer as primer for the paint layers. The structurally consolidation of the adobe masonry surface next to and underneath the paintings provided a solid structure for the treatments to follow. The fragile lime wash layers and the clay plaster layers were stabilized by edging detached fragments with conservation mortar. Little gaps were infilled. To improve the bondage between coat and support, fine voids were filled by grout injections. All conservation mortars contain cellulose-ether as binder and are reversible. Softened and fragile paint layers were structurally consolidated and re-stabilized.

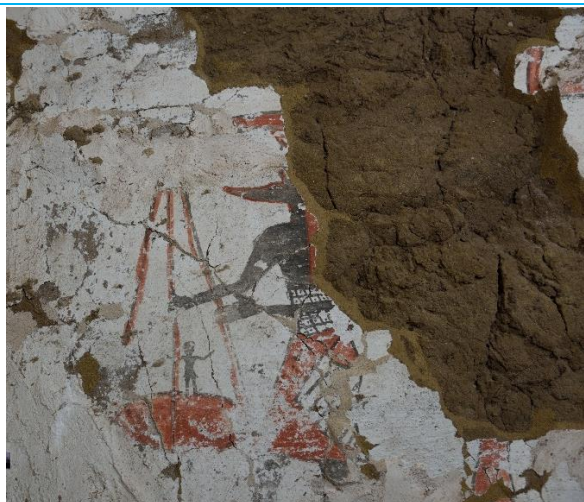
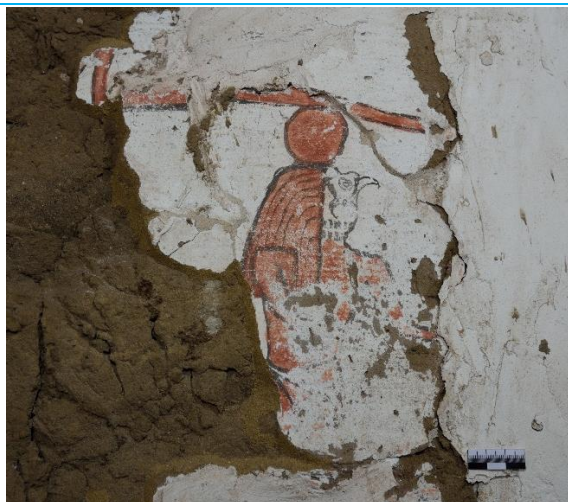
Condition after treatment

Parts of the most vulnerable areas of the artwork could be stabilized. Fragile parts of the wall paintings, which could not be consolidated in the working campaigns, were faced with Japanese paper and cellulose-ether glue. Further treatment is essential to guarantee long-term conservation.

The tomb house is protected by a lockable door mostly covered by sand. In addition, the tomb house window was provided with a new netting wire cover to prevent animals from nesting inside. For the future it would be desirable to establish a maintenance and monitoring programme.
