Conservation of a Roman Tomb House in Tuna el-Gebel, October/November 2020

Heike Pfund, 29.02.2020

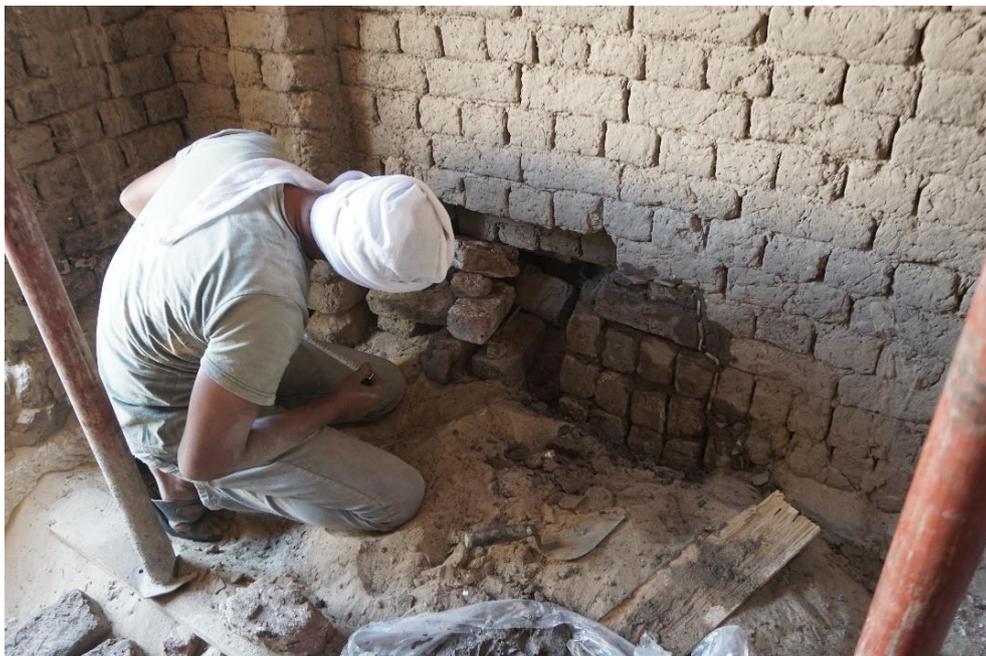
Antechamber, mason repairing the mud brick wall

Mud brick walls were in some places in a state of deterioration and had to be stabilized. Holes were filled with mud bricks and mud mortar, the borders of the repairs were marked by small pieces of pottery.

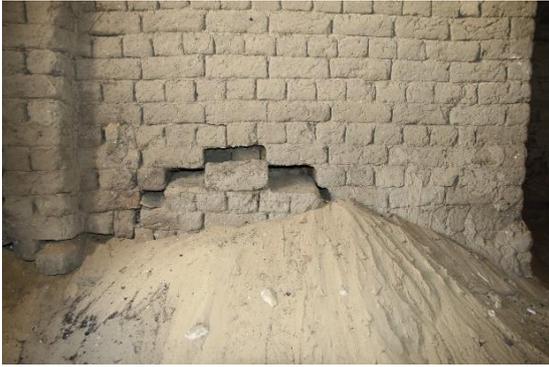
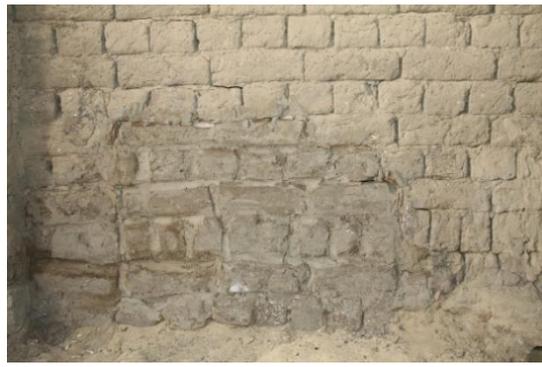
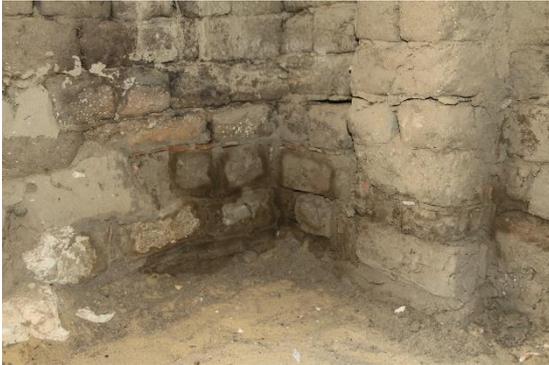
Wall repairs in the antechamber,
east and south walls

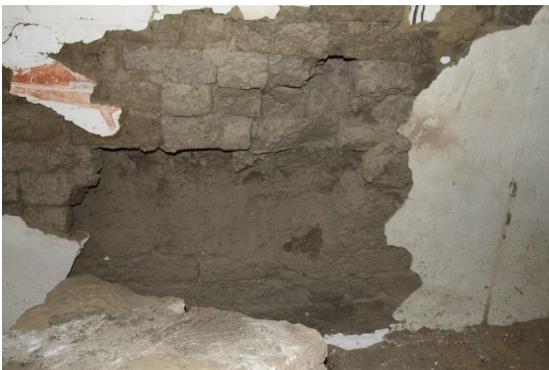
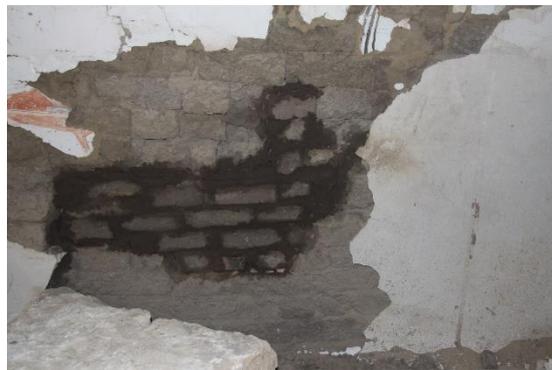
Deteriorated wall in the main chamber, east wall, before and after repair

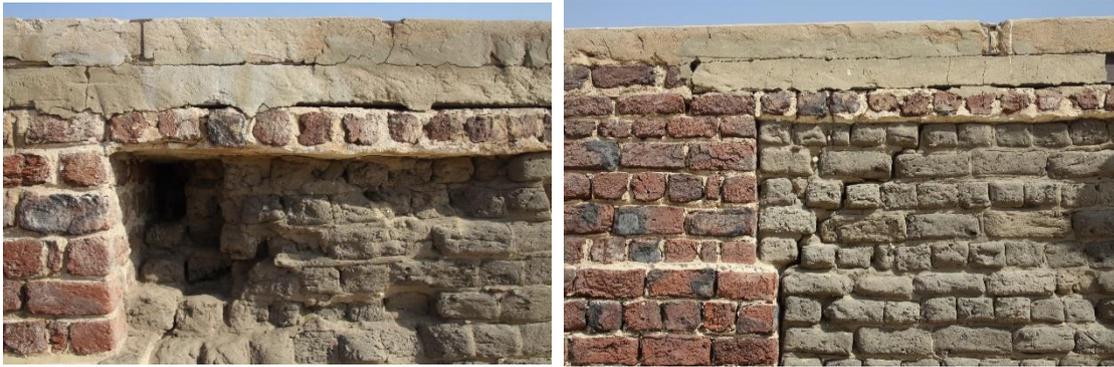
South façade, closing of a hole to prevent animals from settling in

At the façade of the tomb house, some repairs of mud brick masonry were carried out.

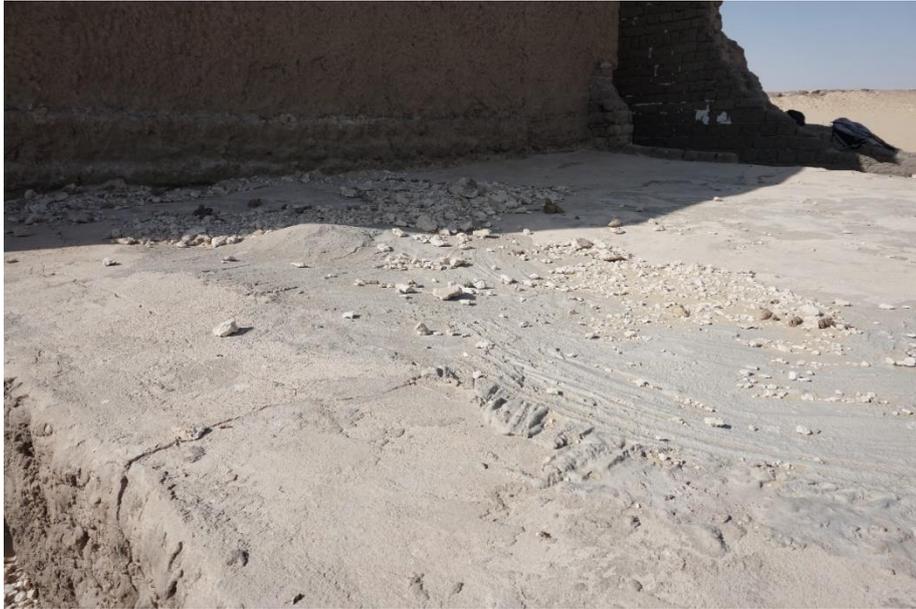
The roof of the antechamber was partly broken, due to degraded wooden beams and perhaps people walking on the weak roof. This had been noticed in February 2018, and during that year repairs were undertaken by local people, closing the hole in the roof.

Collapsed roof area of the antechamber after the repair of 2018

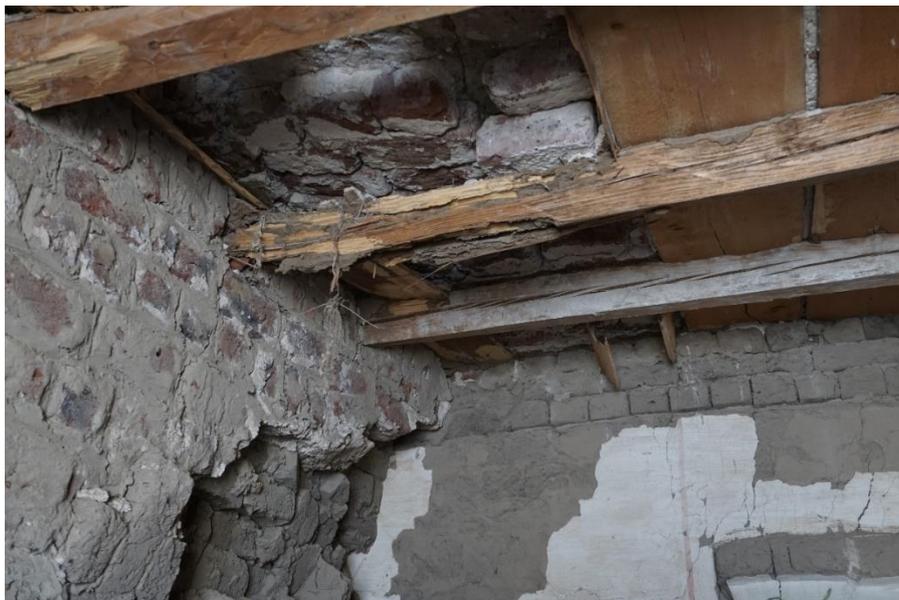
Deteriorated ceiling in the antechamber

It was decided to exchange the two visibly rotten beams without taking off the roof completely. Involved were workers and craftsmen, all with work experience in Tuna el-Gebel. Materials were bought on the local markets in Tuna and Mellawi.

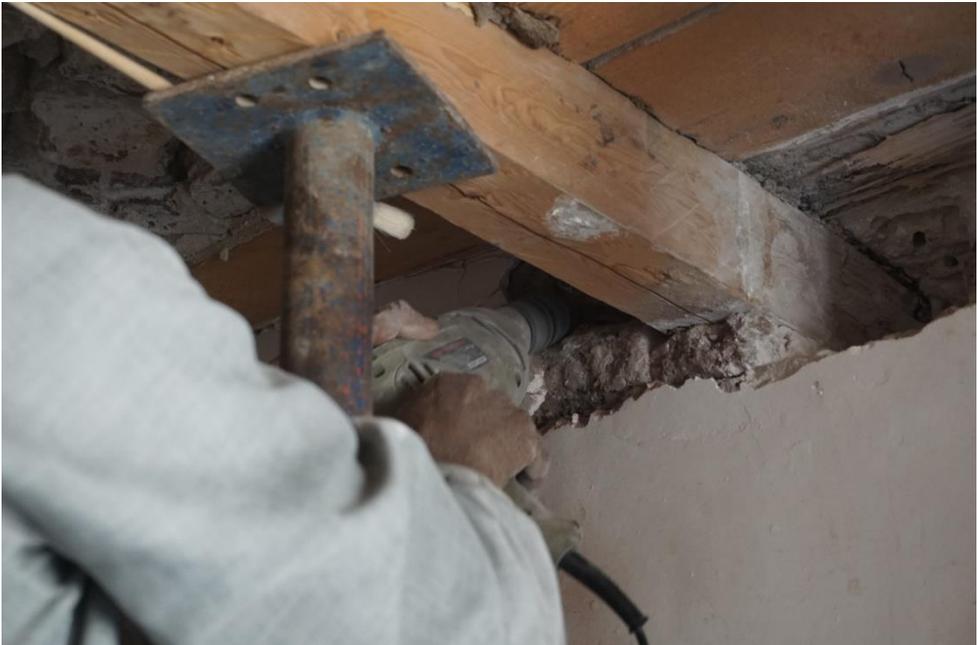
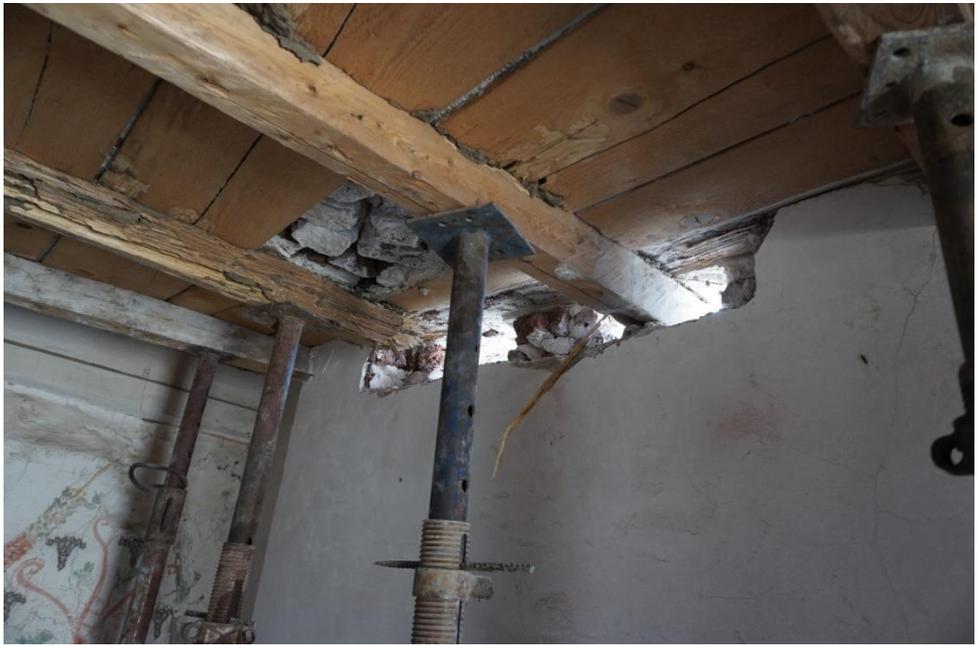
Opening the walls around the beams (top), beams free and ready to be taken out (bottom)

After having stabilized the roof by jacks, walls around the rotten beams were opened. A drilling machine was used to open the walls around the beams, instead of hammer and chisel,

to minimize vibrations. Then the two rotten beams could be slided out, and the new beams slided in.

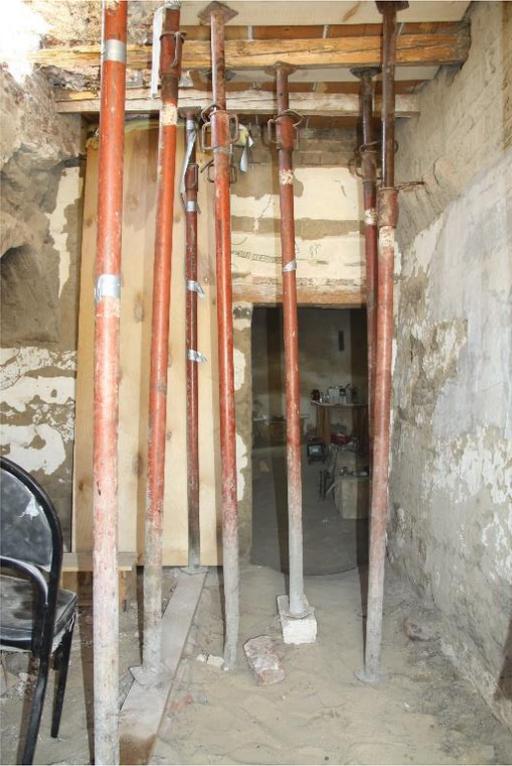
Roof supported by jacks

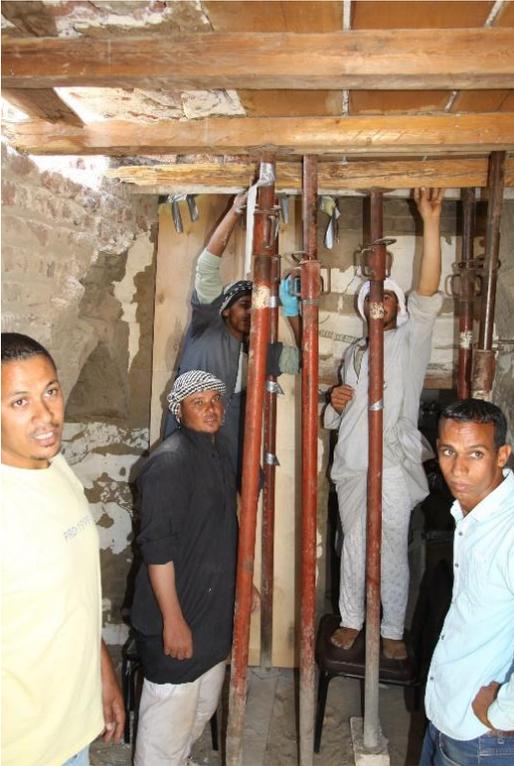
Sliding out the rotten beam

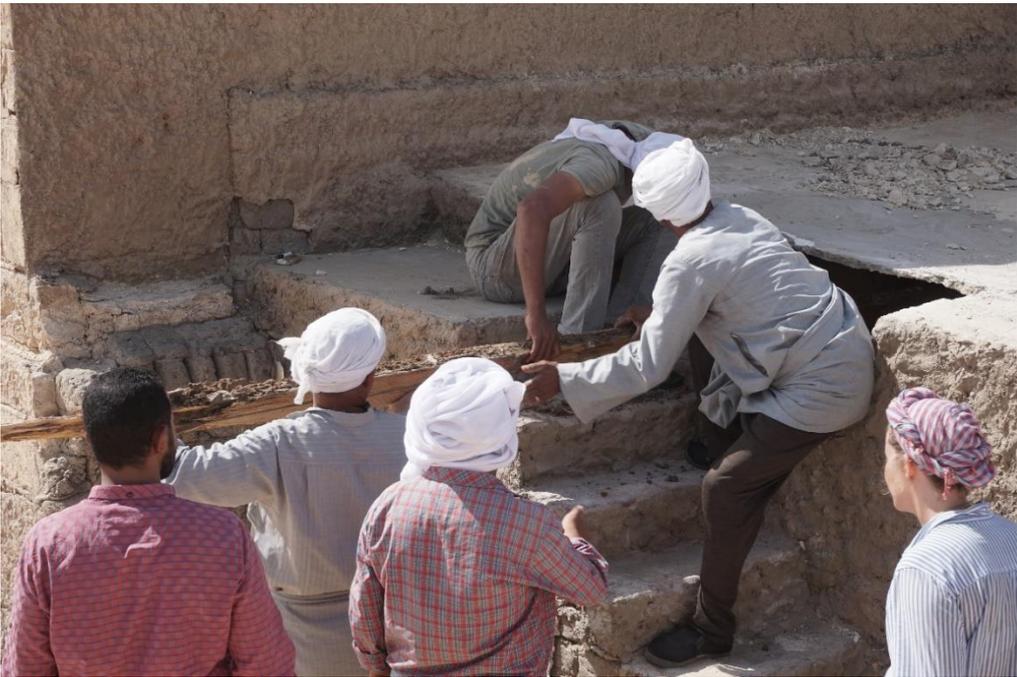
Receiving the rotten beam

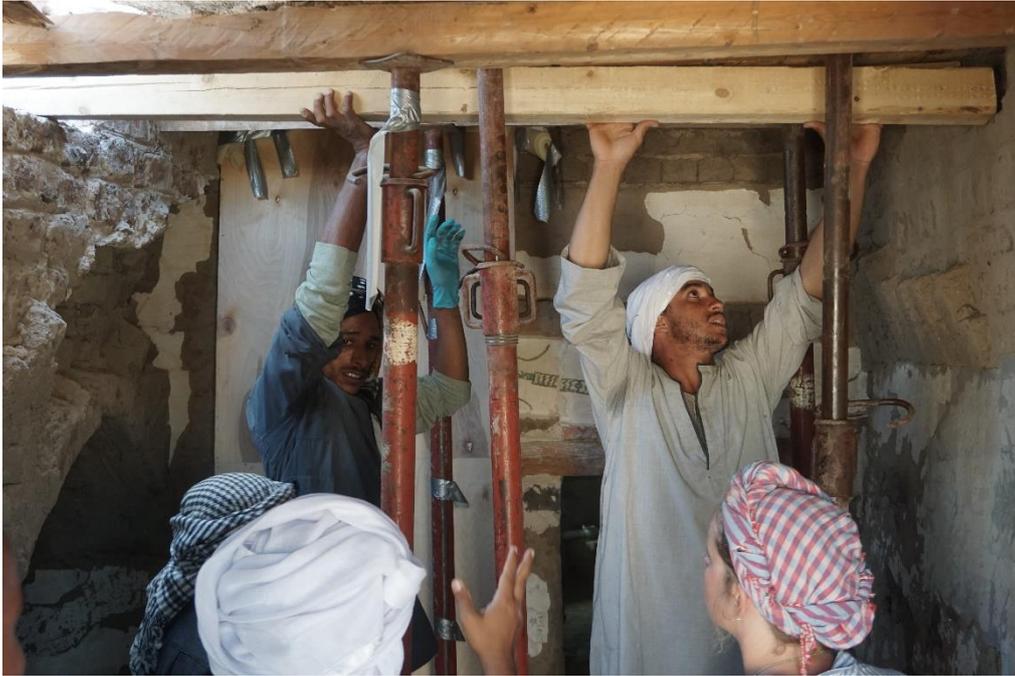
Sliding the new beam in

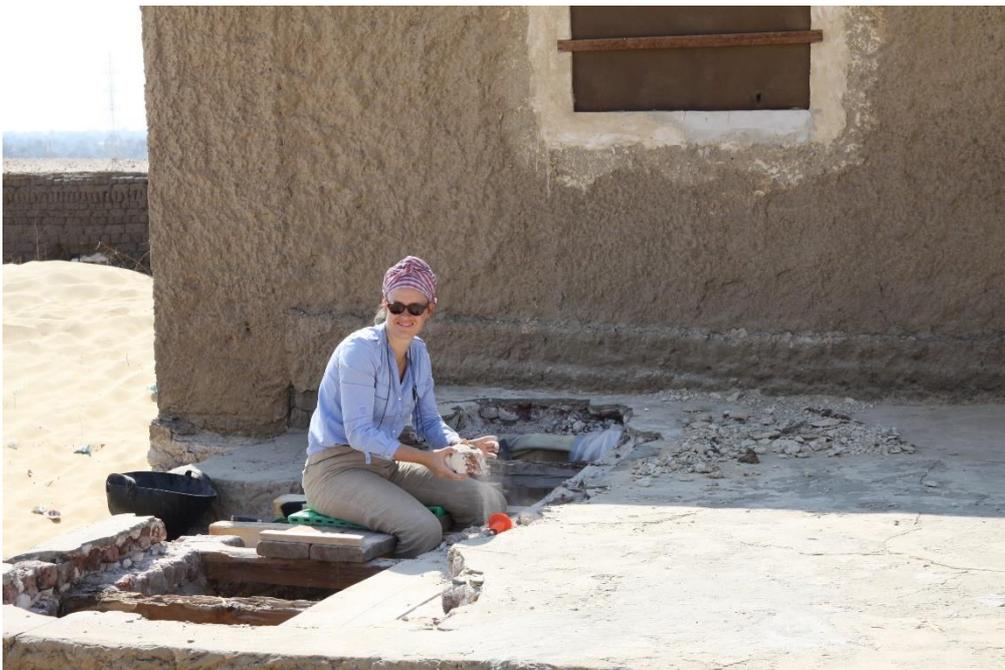
After the rotten beams had been taken out, it became obvious, that large parts of the wooden planks above the beams were also damaged, in areas directly above the beams, invisible from beneath; some planks were about to break down. As a consequence, the roof was then opened, completely removed and rebuilt with wooden beams, wooden planks, and red bricks, covered by a layer of lime plaster.

Katharina Westphalen dismantling the roof

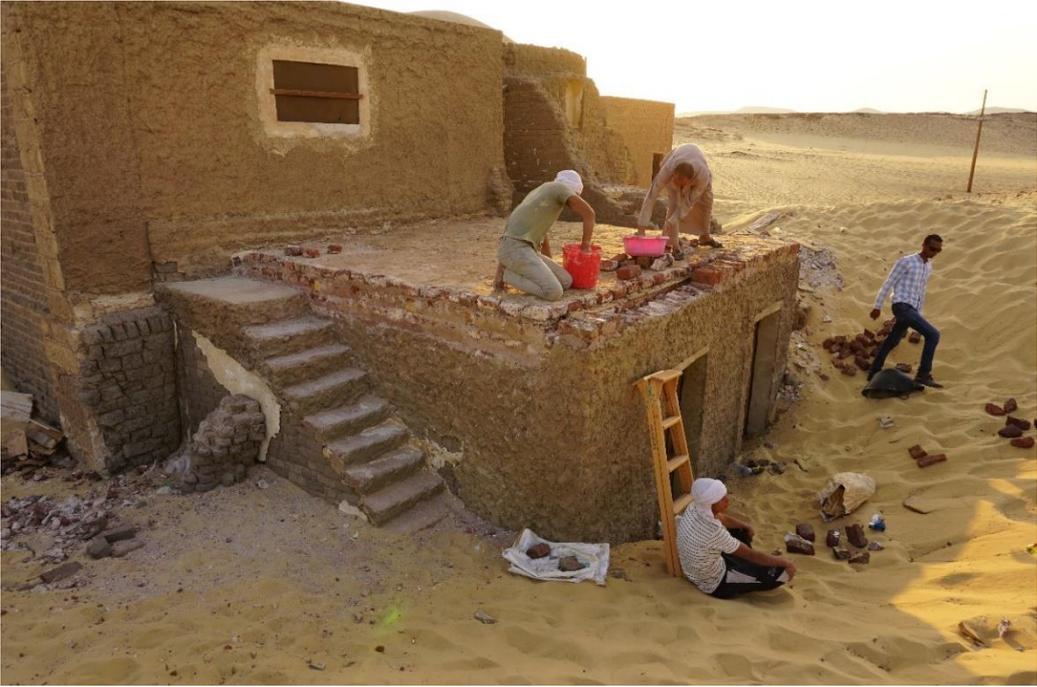
Final work on the new roof: laying red bricks in lime mortar

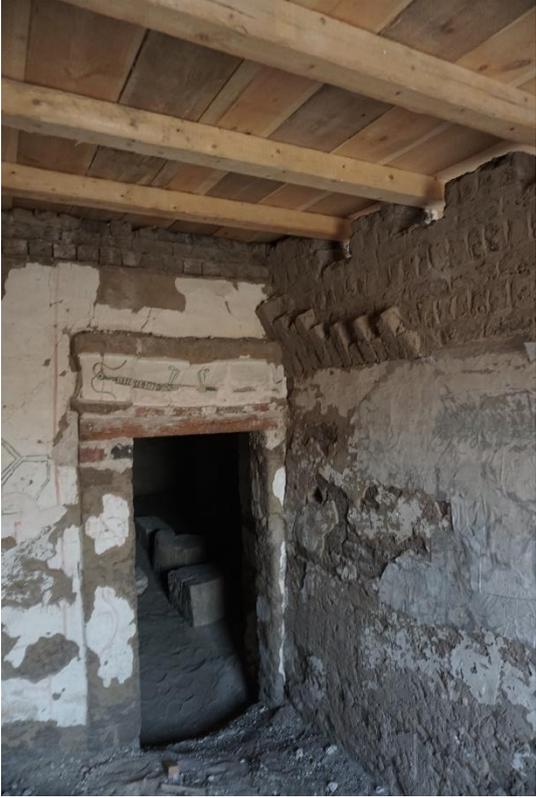
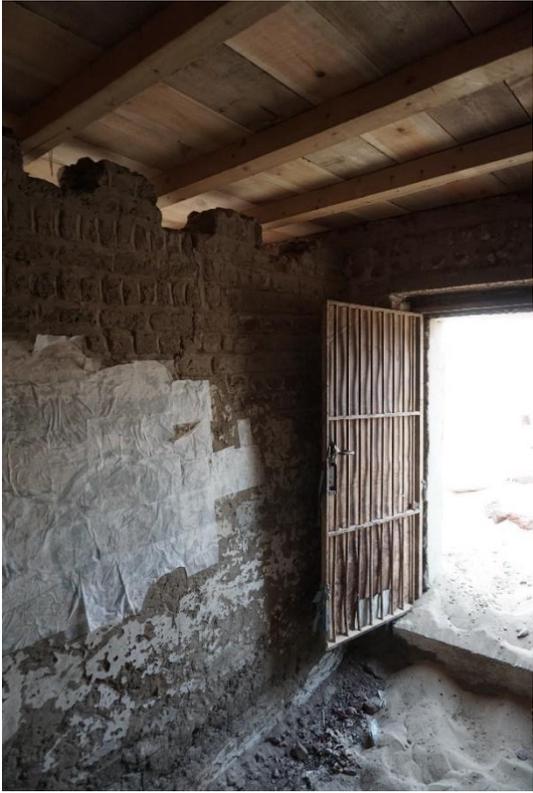
New woodwork of the roof; interior wall relieved of pressure from the roof

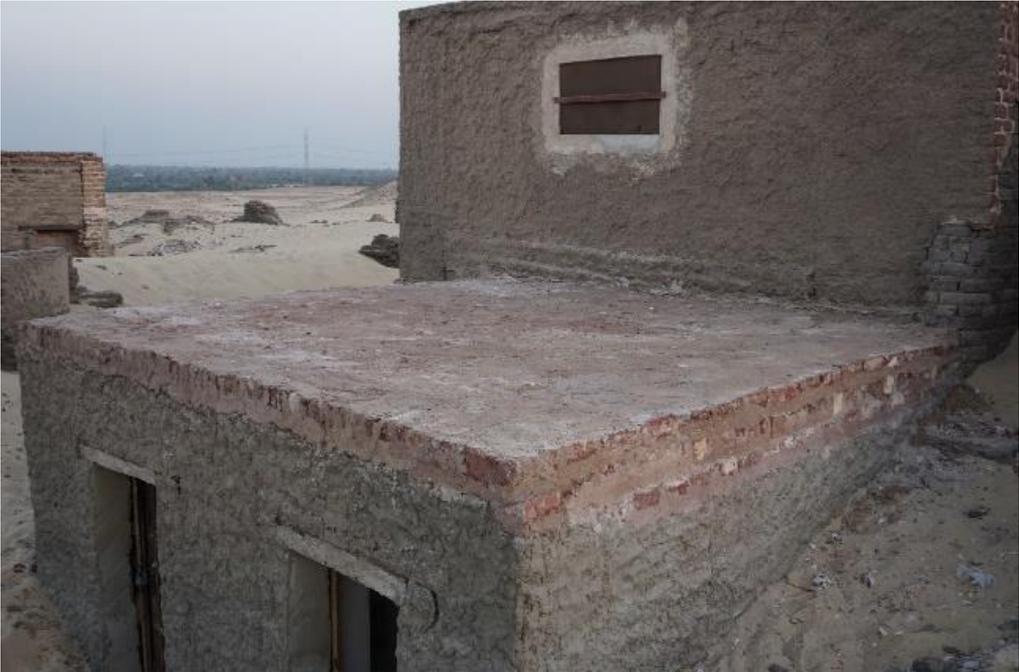
The new roof of GB 33A/B, antechamber/chamber
