## Conservation of a Roman Tomb House in Tuna el-Gebel, October/November 2020

Heike Pfund, 29.02.2020

### Stabilization of Wall Plaster - Preparation for the Conservation of Wall Paintings

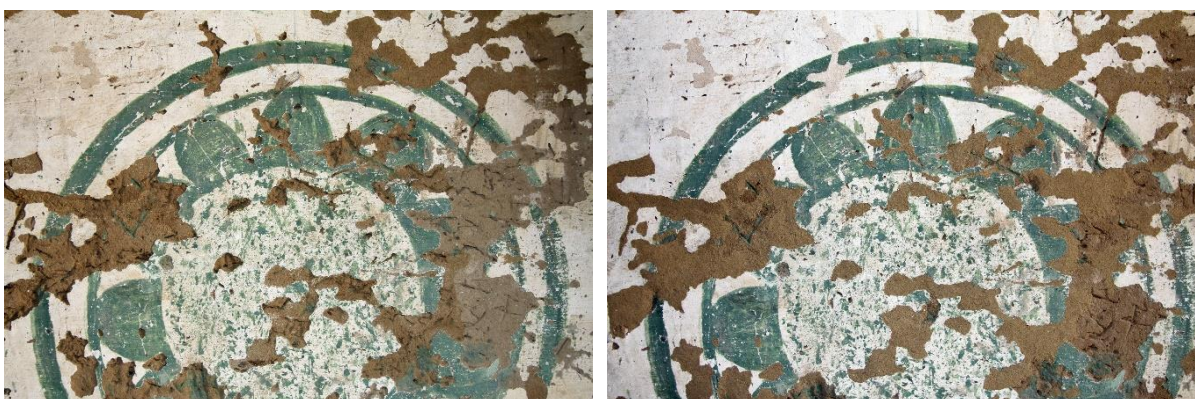
Before plaster conservation (left) and after (right). Cracks and holes were closed and edges rendered

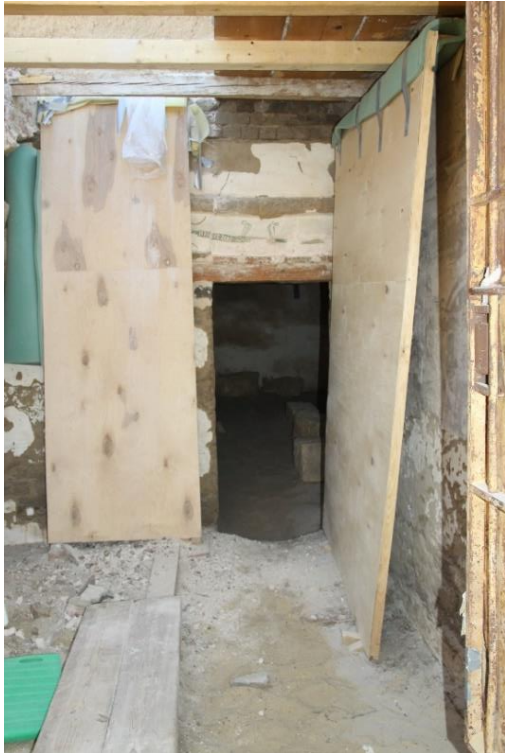
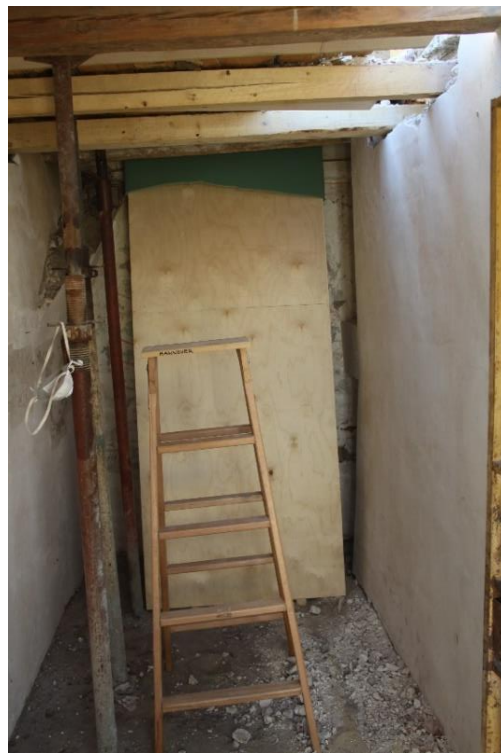
Antechamber (GB33A) (left) and GB33B (right) with protective shields during roof work

Once the wall plasters had been stabilized, Japanese paper was glued on the painted surfaces for protection during roof works. Also, protective shields made from wood and plywood had been manufactured to stand in front of walls with wall paintings, to prevent damage by falling bricks and debris, whenever roof work was ongoing.

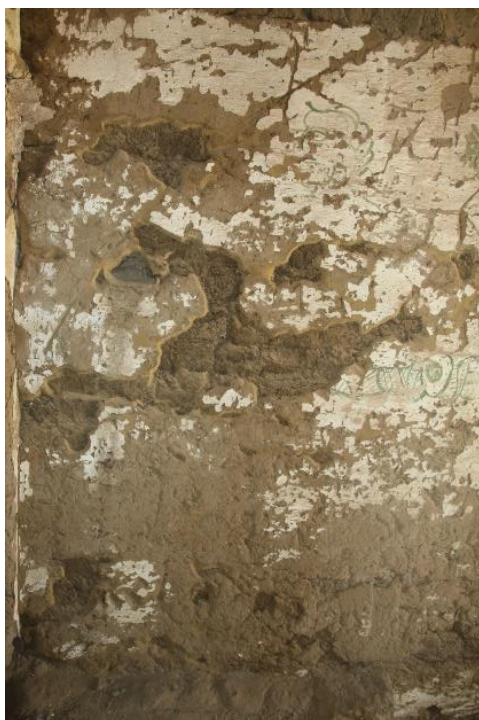
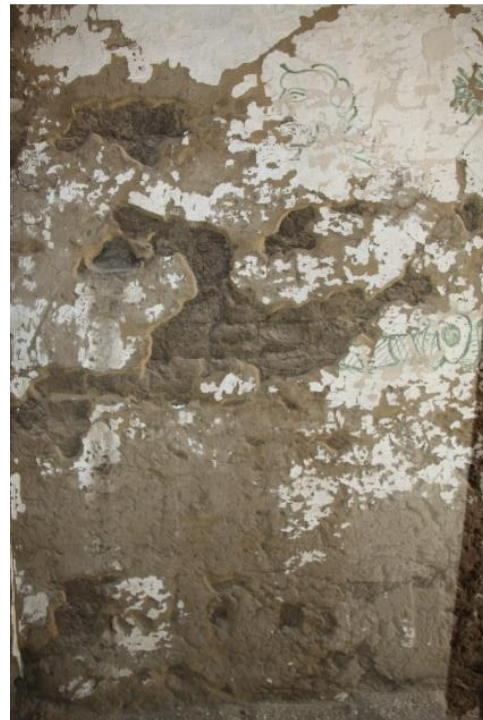
Antechamber, west wall, left part, before conservation (left) and after (right)

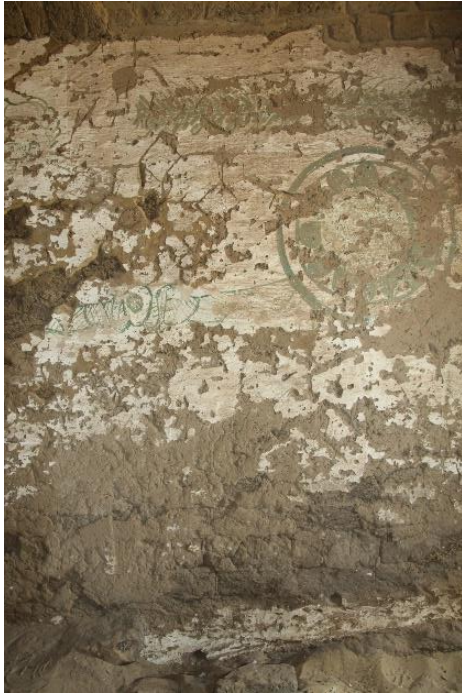
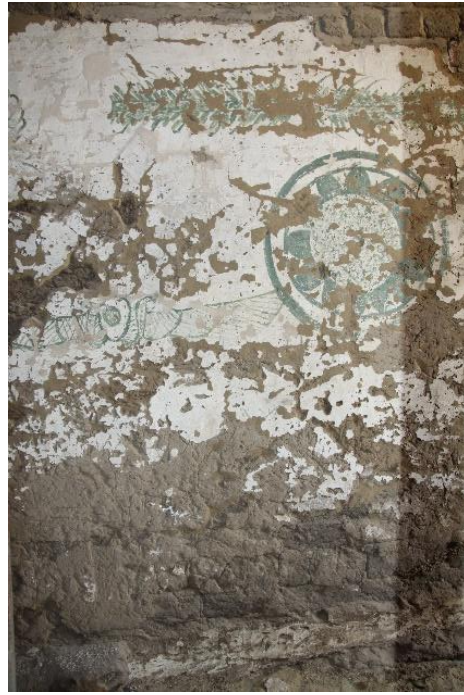
Antechamber, west wall, middle part, before conservation (left) and after (right)

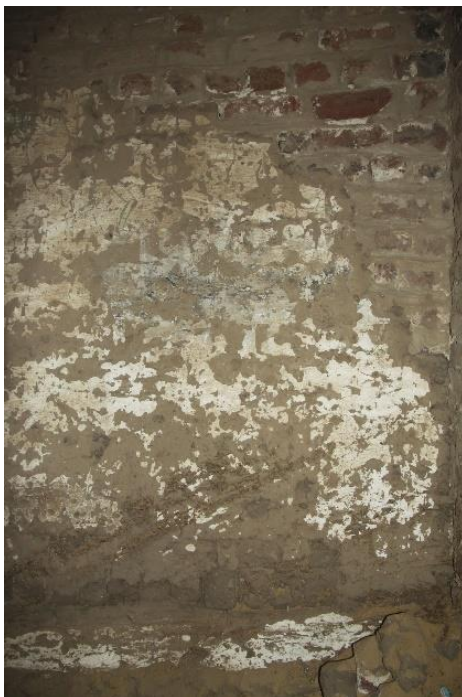
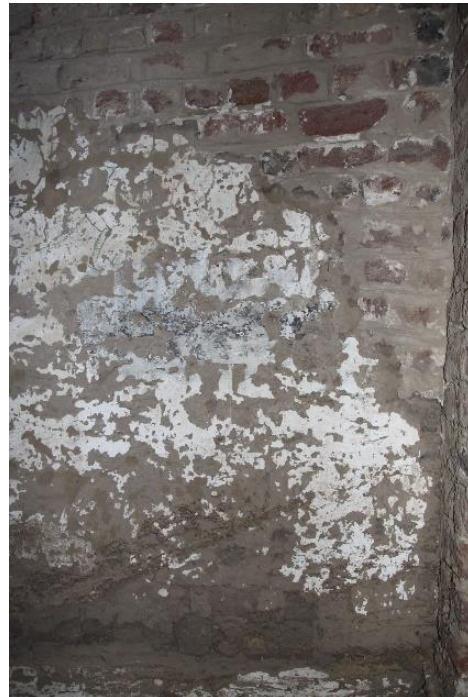
Antechamber, west wall, right part, before conservation (left) and after (right)

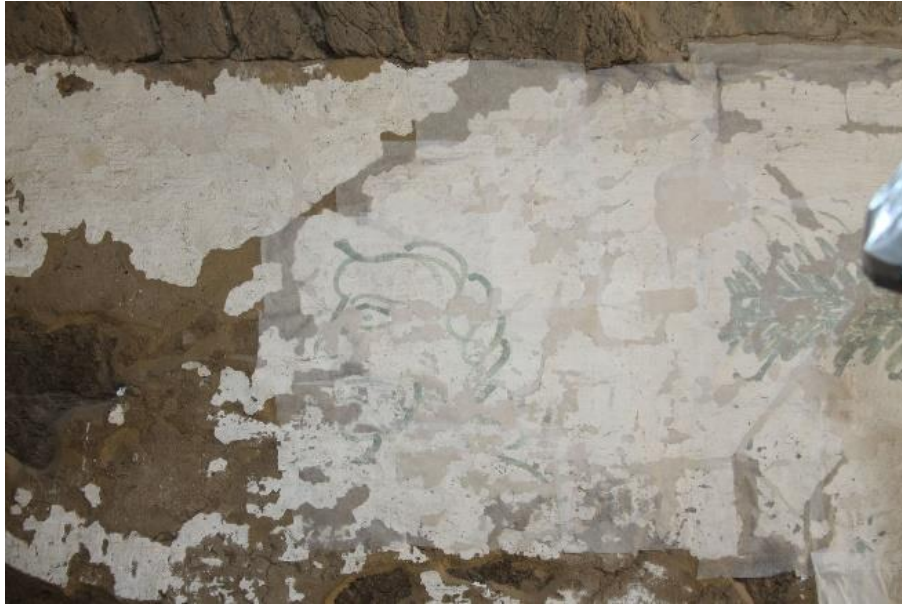
Antechamber, west wall, after facing with Japanese paper

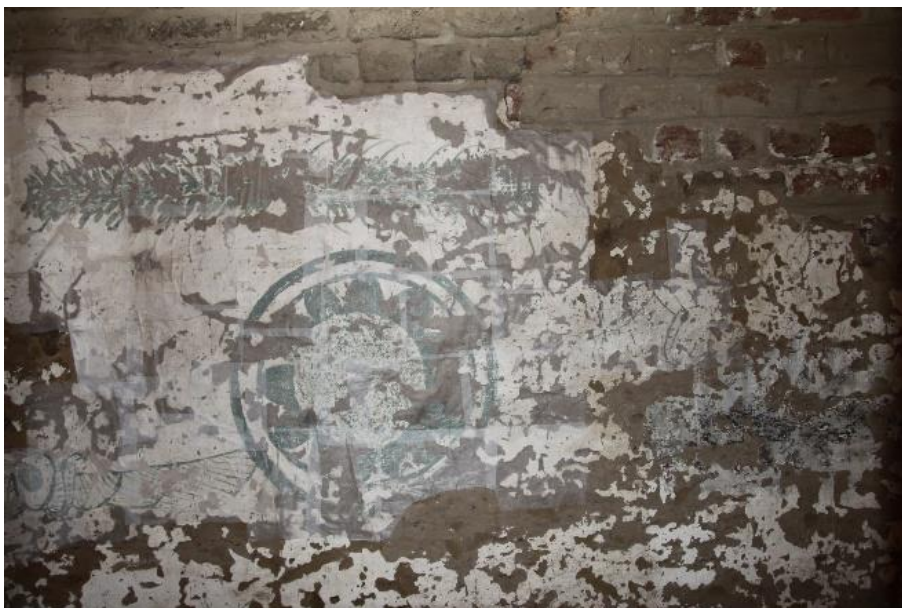
Antechamber, west wall, after facing with Japanese paper

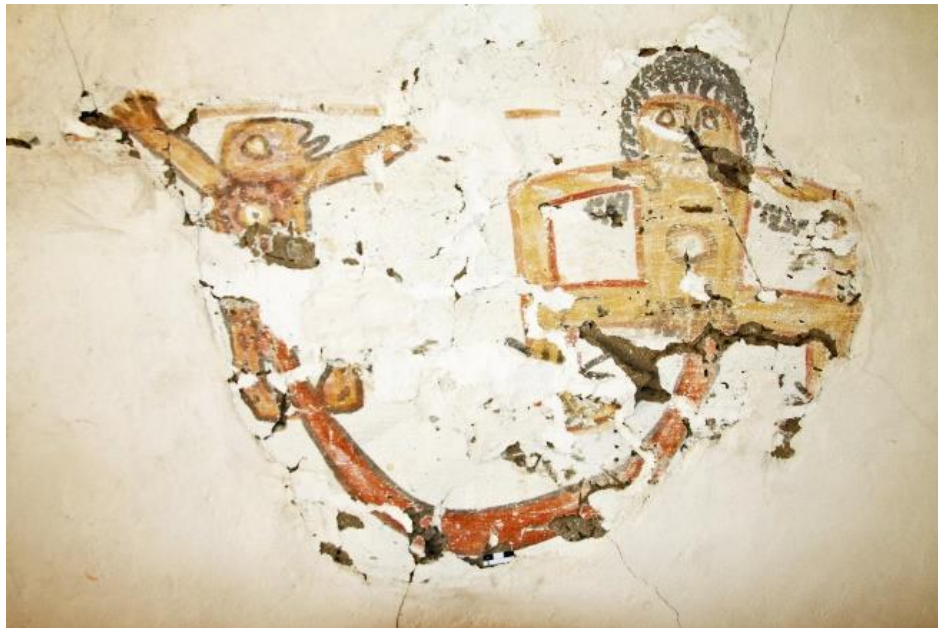
Adjacent chamber (GB33B) east wall, before conservation treatment

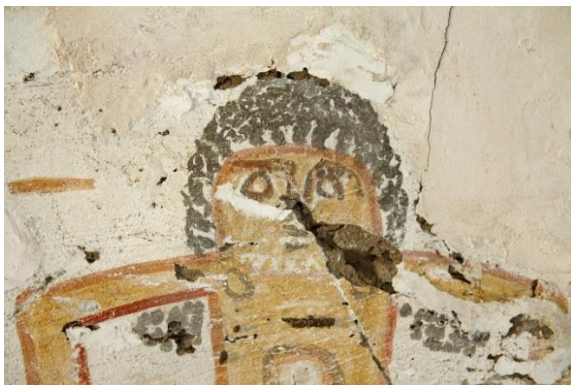
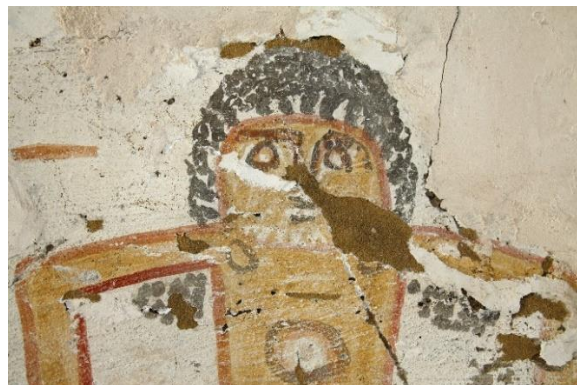
GB33B, east wall, detail before and after conservation treatment of the plaster of 2019

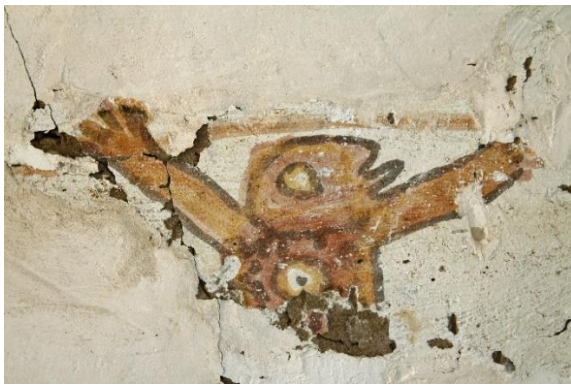
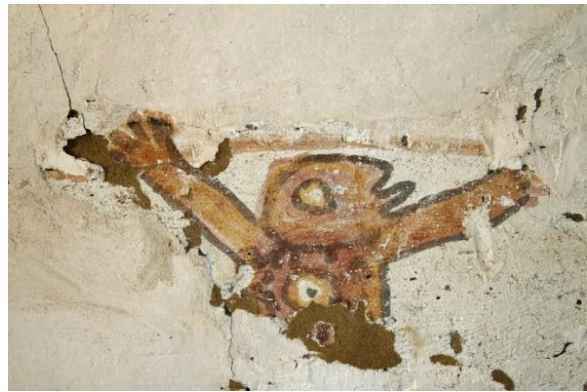
GB33B, east wall, detail before and after conservation treatment of 2019

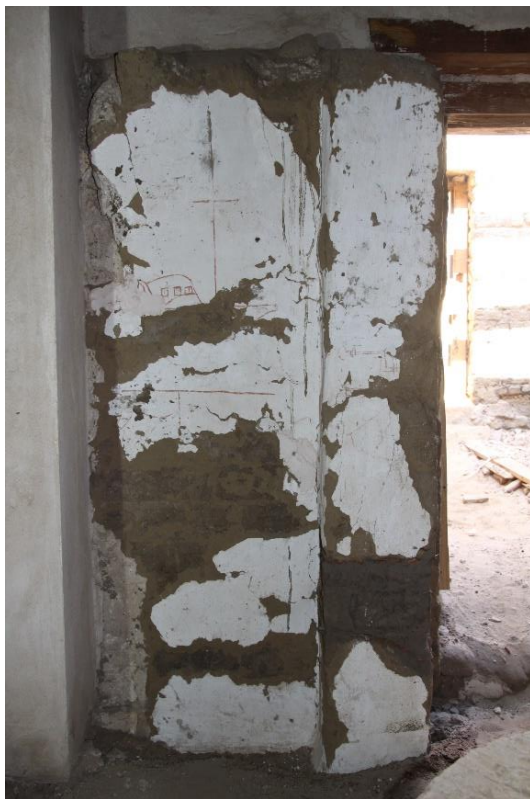
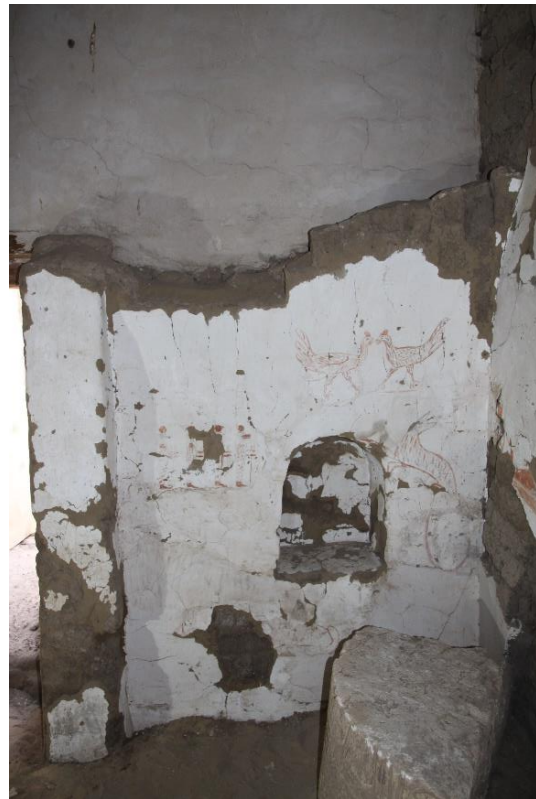
Main room, ground floor, south walls after conservation of 2019

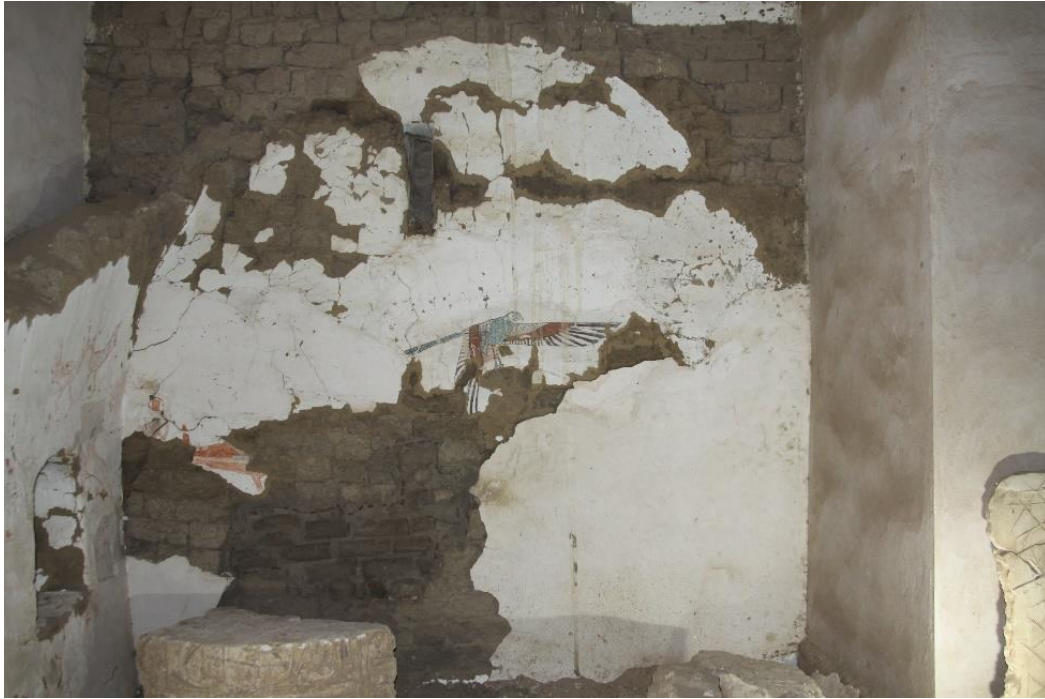
Main chamber, east wall after conservation of 2019
