## Conservation of a tomb house with wall paintings in the necropolis of Tuna el-Gebel, 2019–2021

### Campaign of 2021

### Works of 2019 - Repairing the architecture and pre-consolidating wall paintings

### [Works of 2021 – Conservation of the wall paintings](#)

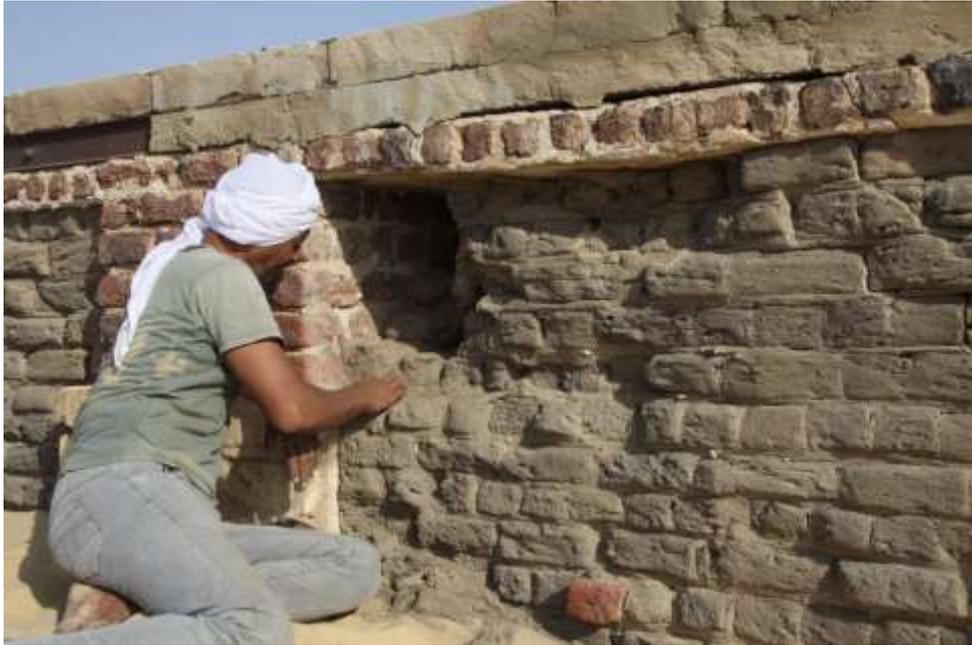
Repairing the ancient mud brick masonry under the roof from the 1930s (2019)

To safeguard the tomb house, and as precondition for the conservation of wall paintings inside, the architecture of the Roman tomb house GB 33 (M 20/SE) had to be repaired. This included construction work on the damaged roof of the antechamber, through which the main tomb can be accessed, and the adjacent chamber. The ancient mud brick walls (adobe masonry) were excavated in the 1930s and are since then exposed to the elements. Erosion by wind and sand is in constant progress, and wild animals like birds, bats, snakes and insects seek refuge in dilapidated walls. Closing gaps in the masonry strengthens the walls, and was part of the project. In the aftermath of the 1930s excavation, some tomb houses were fitted with new roofs, as most of the roofs had been collapsed earlier. Many roofs were constructed with metal beams, burned bricks and plaster, only some received a wooden ceiling like the antechamber and the adjacent chamber of our tomb house.

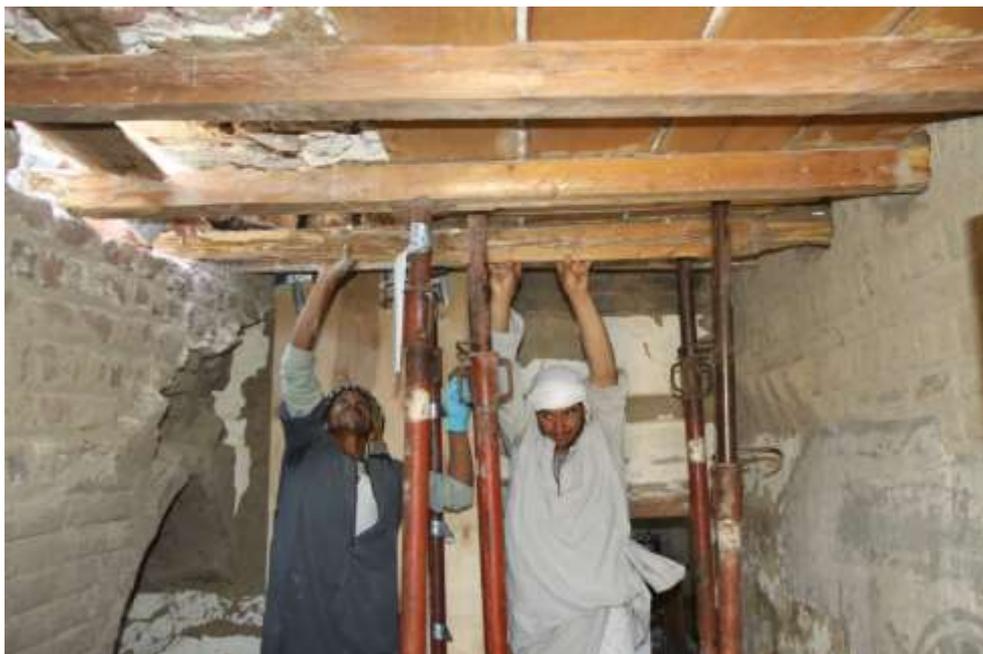
Taking out rotten beams in the antechamber by sliding them sideways (2019)

The antechamber of the tomb with adjacent chamber had a common roof made of wooden beams and boards, covered by a layer of burnt bricks and cement. Two ceiling beams were broken, and the entire roof became a danger for the delicate painted mud brick walls. Also, visitors to the site were in danger, because they often climb up on roofs, if easy access is given. The broken roof was step-by-step dismantled and a new roof set up. An illustrated report about the renewal of the roof can be found on this website under “conservation”<sup>1</sup>.

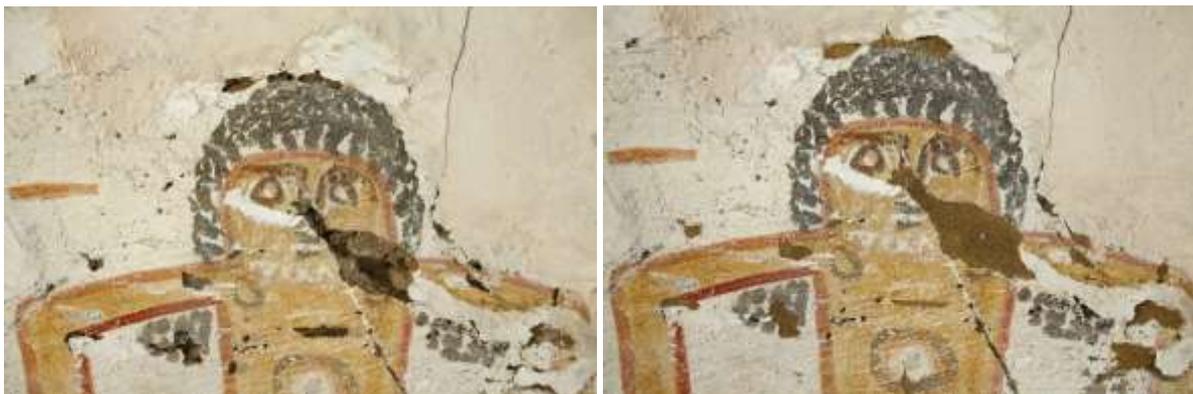
Painting on the dividing wall between antechamber and adjacent chamber, before (left) and after pre-consolidation of 2019 (right)

Before the roof could be touched, emergency conservation measures were required on the wall paintings inside the antechamber and the adjacent chamber. Areas of loose mud plaster and lime washes were consolidated and, in addition, protected by a facing - Japanese paper was applied by a reversible cellulose glue to keep loose patches in place.

This helped to secure the painted wall plaster during vibrating roof works. A report can be found on this website under “conservation”.<sup>2</sup>

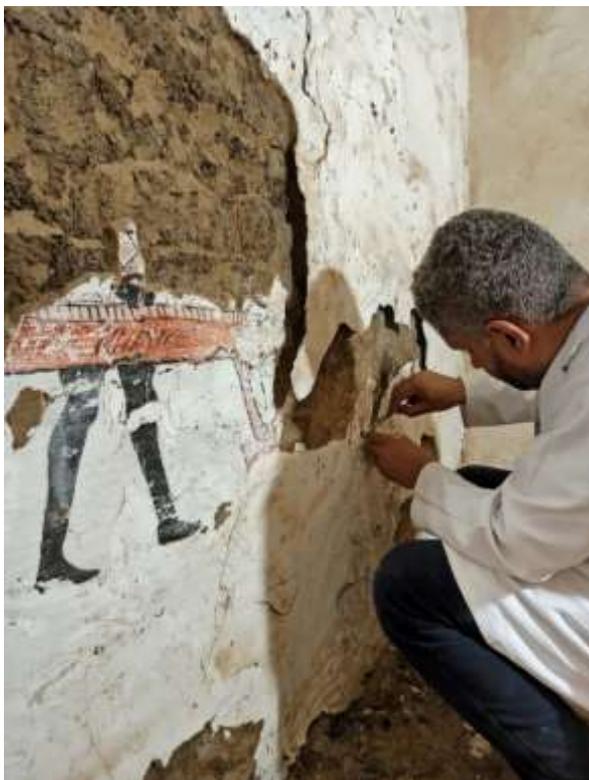
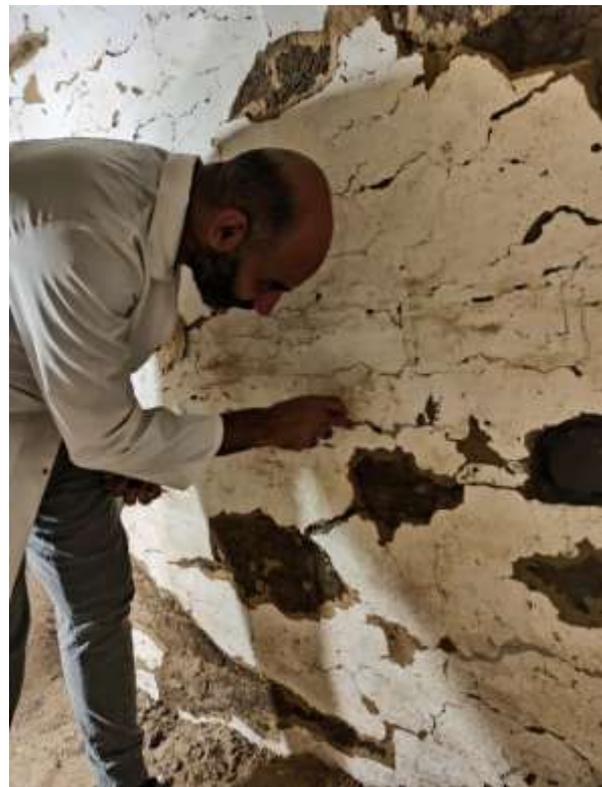
Securing mud plaster by rendering the edges, western walls on ground floor

Important is, that consolidants are not harder or stronger than the rather weak adobe bricks and the soft mud plaster. Therefore, consolidants were based on cellulose ethers in low concentrations, dissolved in ethanol. Ethanol contains only a minimum of water and was thus used to treat the water sensitive earthen materials. In many places in Tuna el-Gebel cellulose ethers had been used for conservation from 2010 onwards, so the endurance of them can be evaluated (further information on this website under “conservation”).<sup>3</sup>

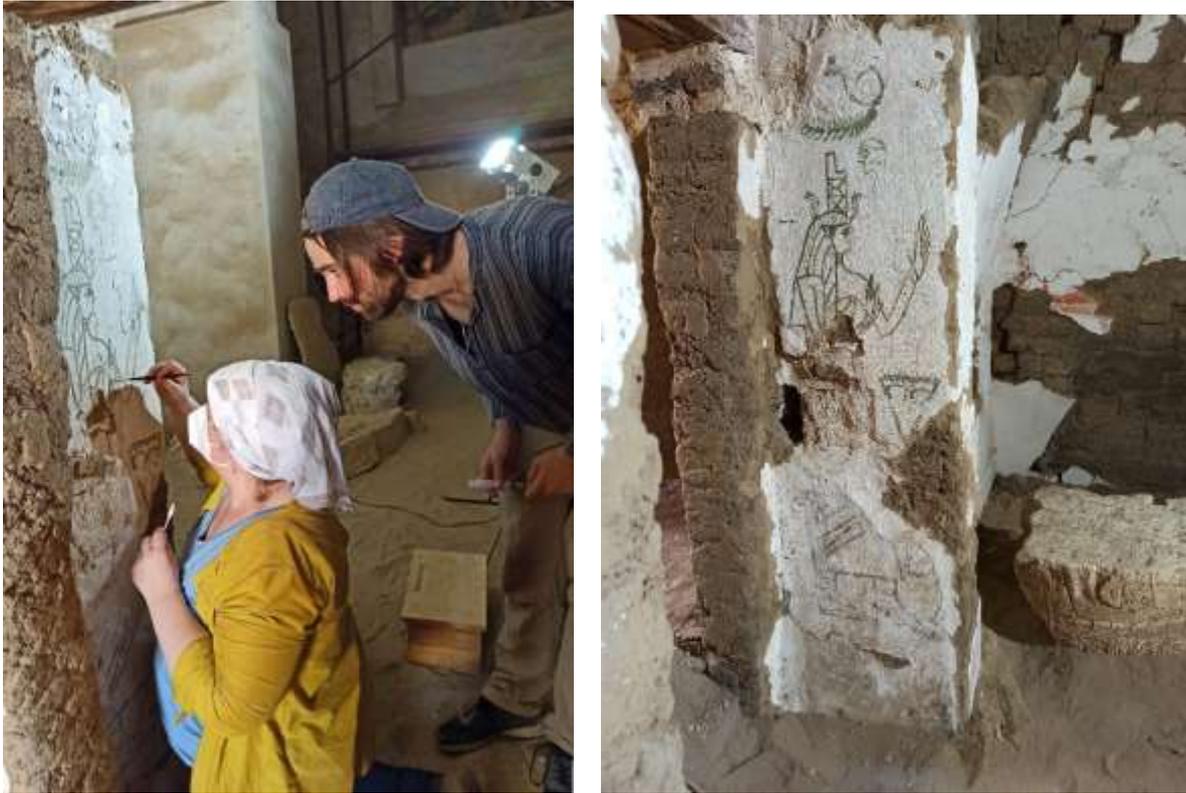
Main room, during (left) and after conservation (right): consolidation of paint layer, rendering plaster edges and grouting were the appropriate measures carried out

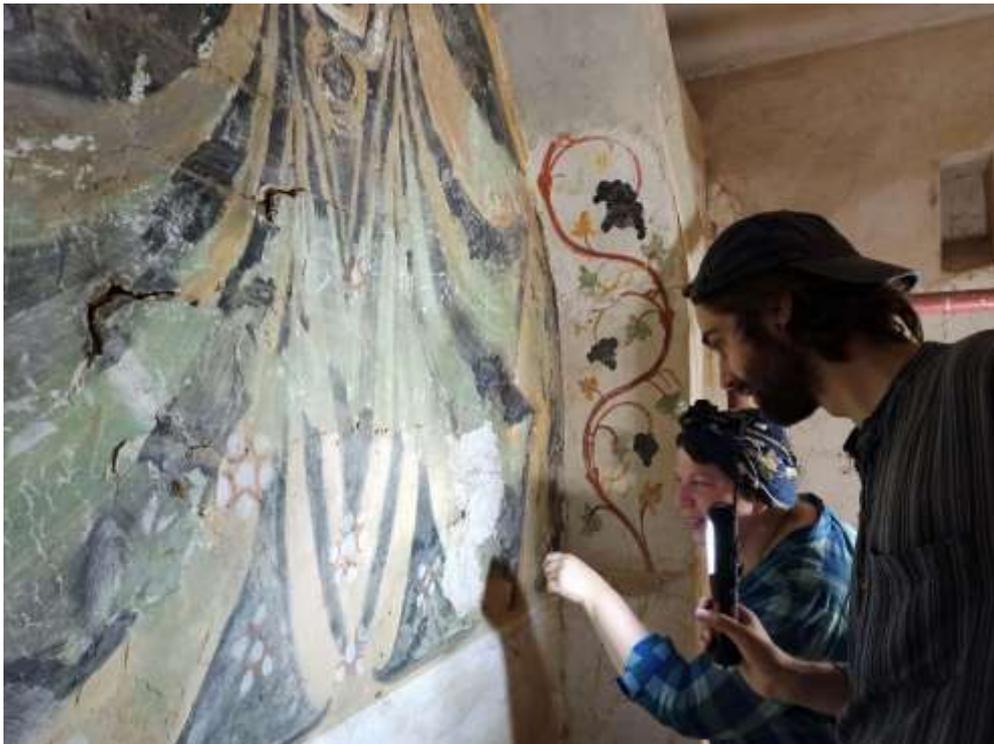
With lots of man-power the pieces were moved to the side and a small scaffolding could be set up in front of the south wall. Here the bulging plaster indicated, that it had separated from the wall and was about to fall.

Examination of the actual condition of the plaster at south wall, first floor

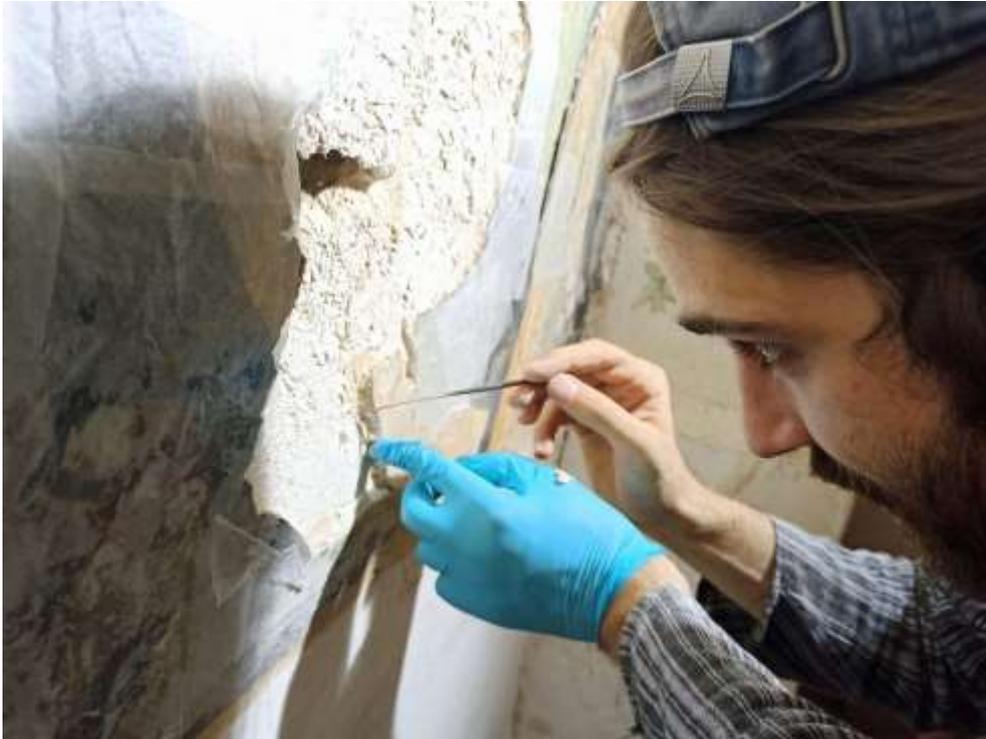
Rendering plaster edges after the facing had been applied

Huge hollow spaces between detached Roman lime plasters and the adobe masonry had to be reconnected to prevent further losses. As a first step, edges of plaster were secured by rendering with a conservation plaster. Fragile areas were pre-secured by a Japanese paper facing.

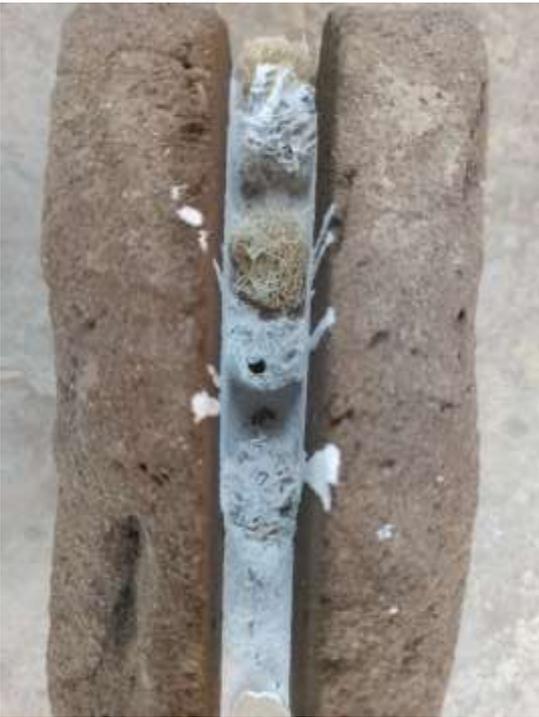
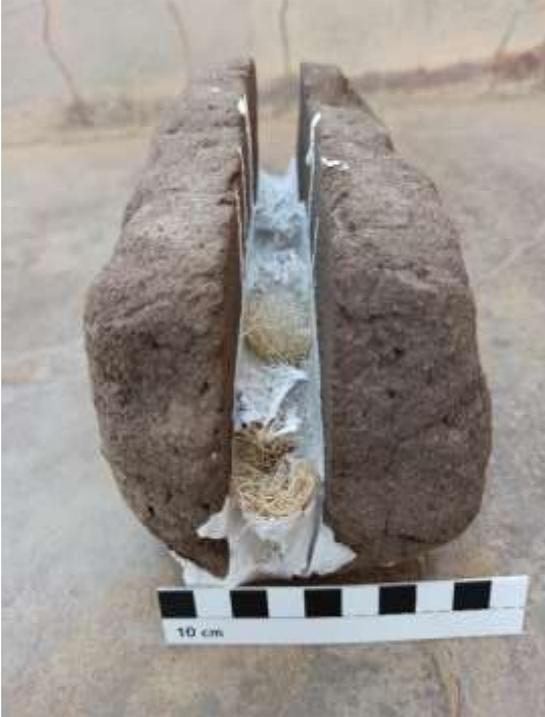
Grouting tests with Luffa pieces, filled between two mud bricks found in the desert

In our case the hollow areas were so big, that it was impossible to fill them with liquid grout. Huge amounts of grout filled in the hollows would have a dissolving effect on the masonry made of earthen materials. To reduce the amount of grout and thus reduce the amount of water, tests with “space-holders” were made, in order to fill the hollows by using less grout. Locally available are Luffa sponges, which were cut in small pieces, formed to balls and filled alternately with the grout between two mud bricks, which we had found laying in the desert. Results were good and the method was adopted. Nevertheless, all preparative work took time, and the grouting had to be done in layers, letting each layer dry out before continuing. So we could achieve a stabilization of the painted plaster at south wall, but not a complete consolidation.

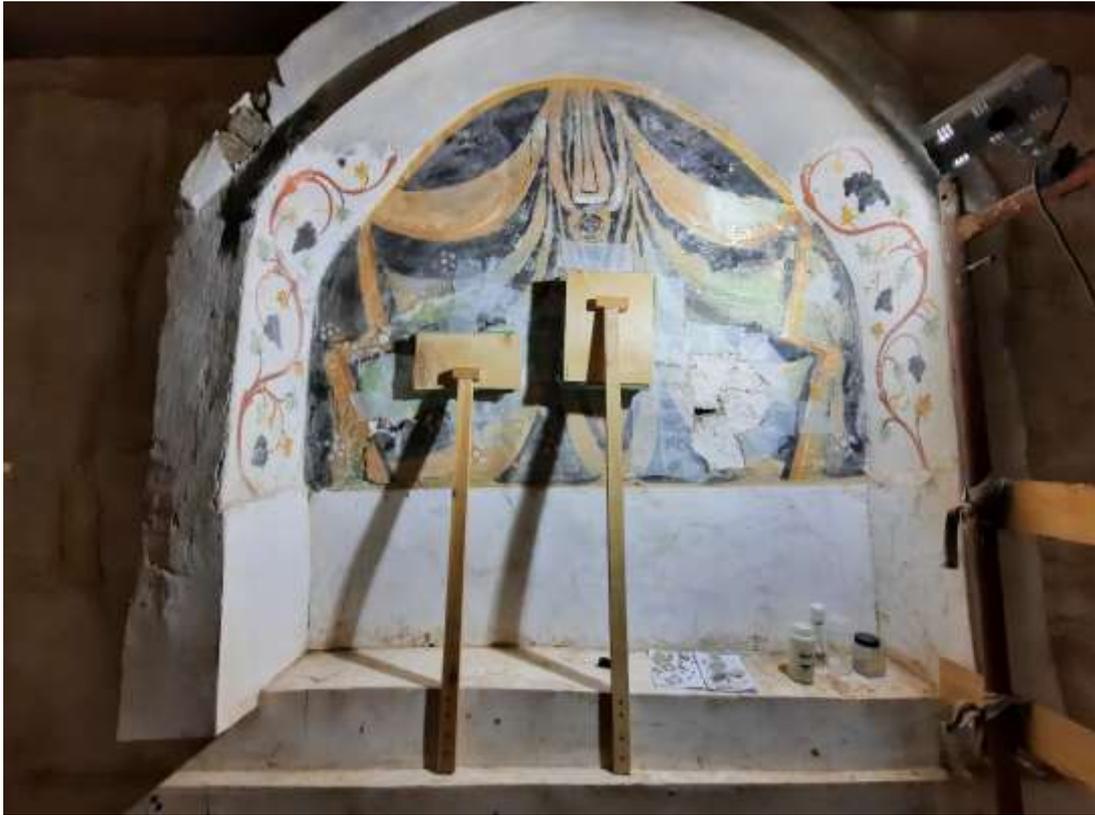
Support system set up before grouting

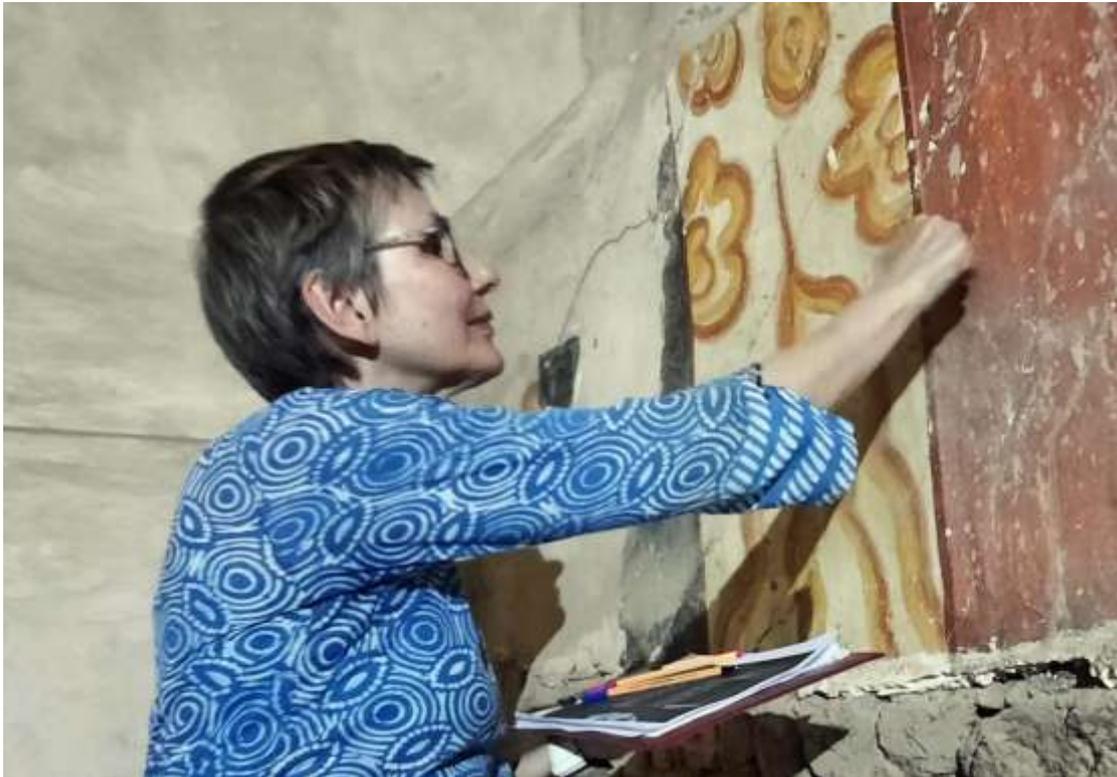
Percussion examination of Roman plaster

The Roman wall paintings on East and West walls could be examined from a ladder, and the condition was documented. Areas with loose plaster pieces were secured by a Japanese paper facing.
