## Tomb no. GB o6 (Gabra no. M 22/SS (LH)) portico

## Tomb no. GB 06 (Gabra no. M 22/SS (LH)) portico

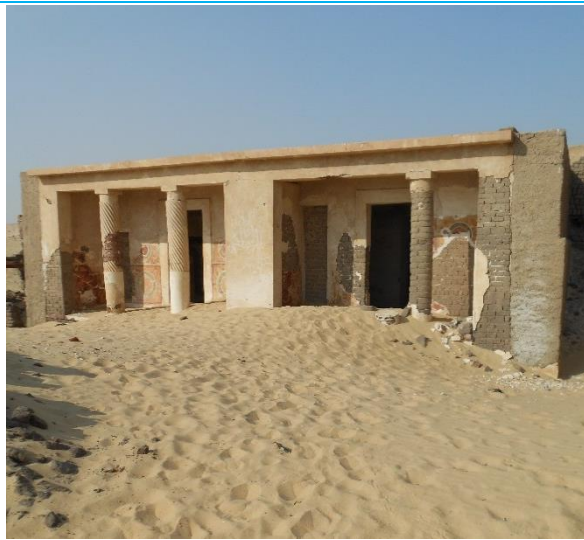
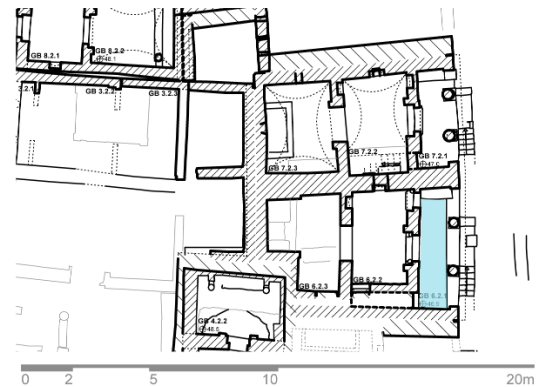
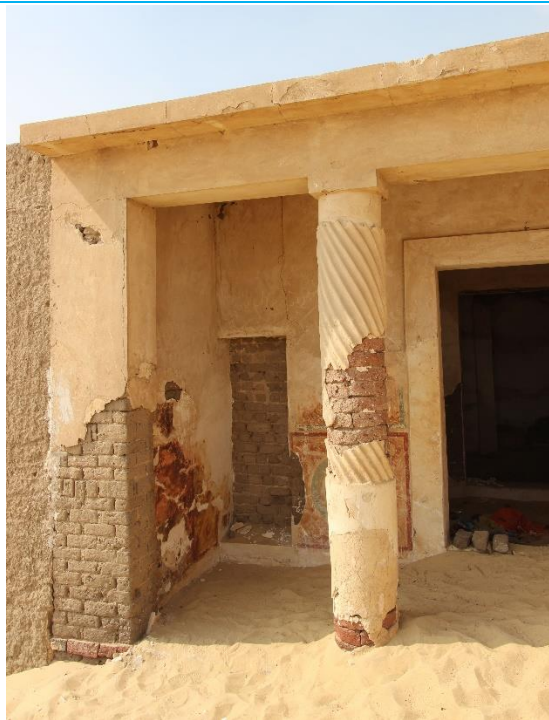
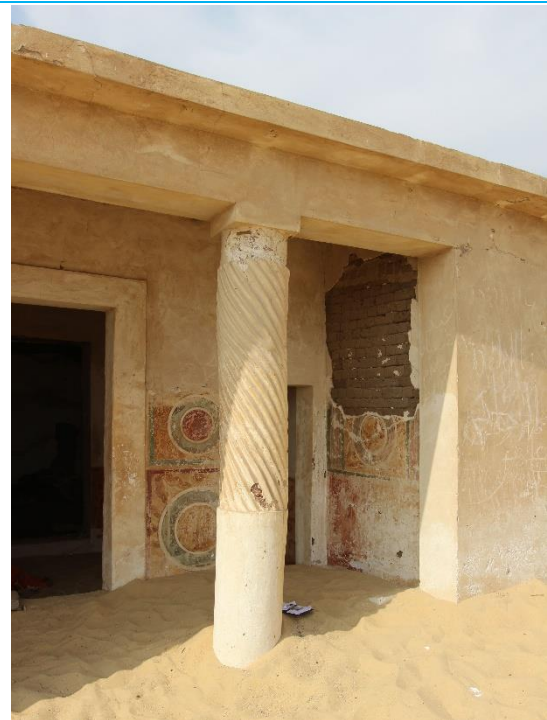
An open entrance room with two columns oriented to the east. The tomb house is built of adobe masonry coated with a layer of lime plaster. The plaster layer was whitewashed in the upper half of the walls. Along the lower half of the walls a second thin plaster layer was applied and decorated with painted framed cassettes with imitations of stone incrustations. The polychrome painting was carried out directly on the smooth plaster surface.

The lost areas of the original plaster have been closed parallel to the reconstruction of the roof. The repair phase with white plaster was left unpainted.

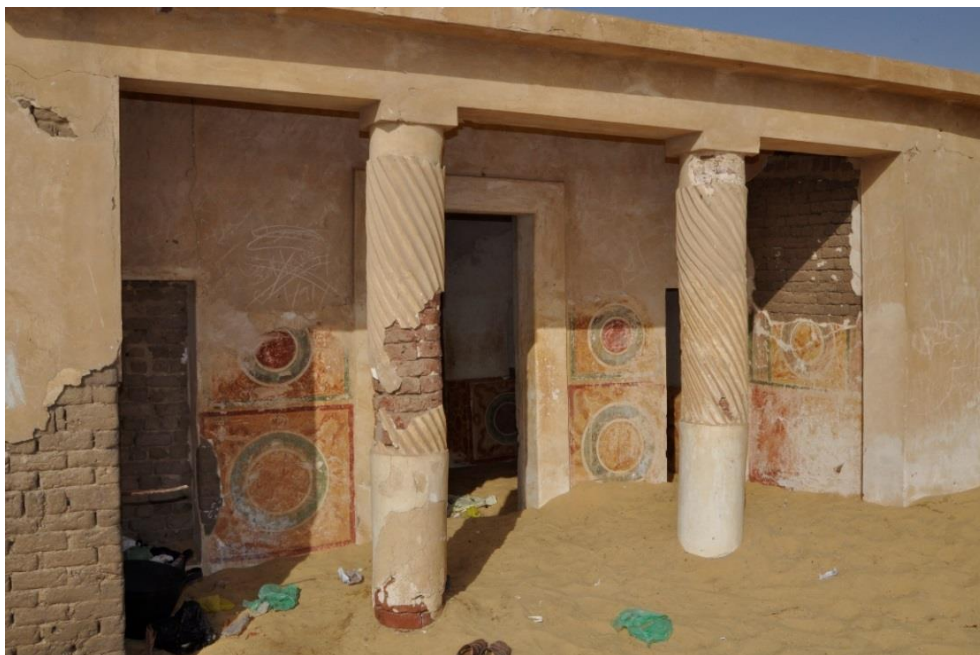
The most vulnerable areas of the artwork could be stabilized. Further treatment is essential to guarantee long-term conservation.

The wall paintings are exposed to the elements and human action. In this respect, it is desirable to establish a maintenance and monitoring programme for the future.
