Tomb no. GB 07 (Gabra no. M 22/SS (RH)) portico

Description of the interior design

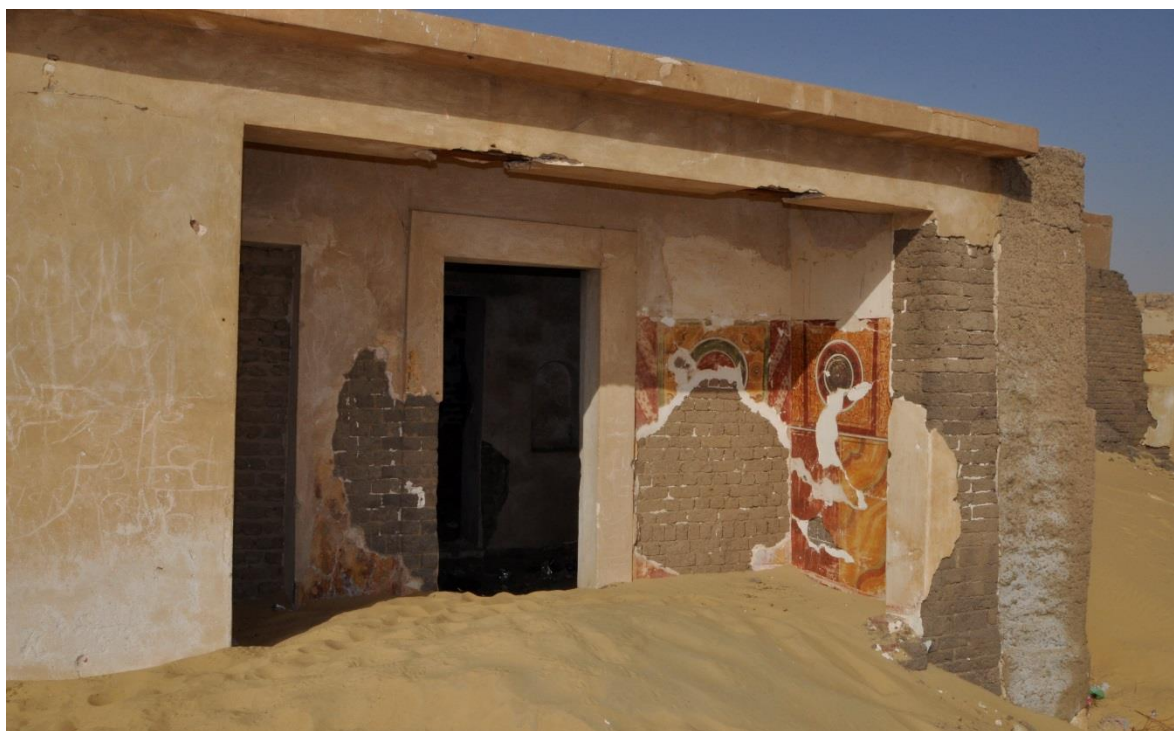
Condition after treatment

The most vulnerable areas of the artwork could be stabilized. Further treatment is essential to guarantee long-term conservation.

The wall paintings are exposed to the elements and human action. Today the second column is lost all the same. In this respect, it is desirable to establish a maintenance and monitoring programme for the future.
