Tomb no. GB 13 (Gabra no. M 05/SS (LH)) anteroom

Tomb no. GB 13 (Gabra no. M 05/SE (LH)) outside

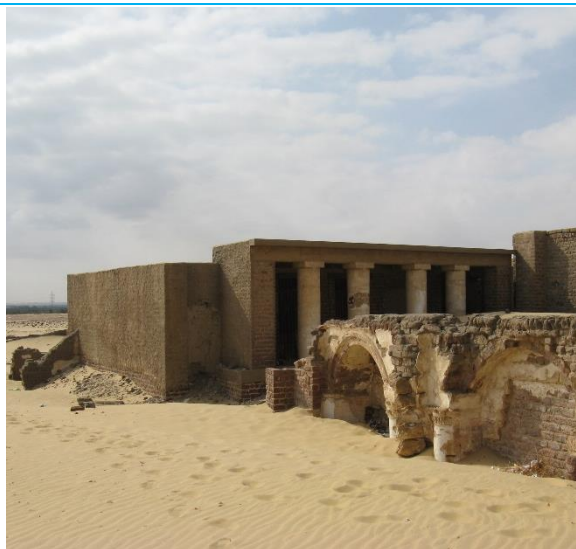
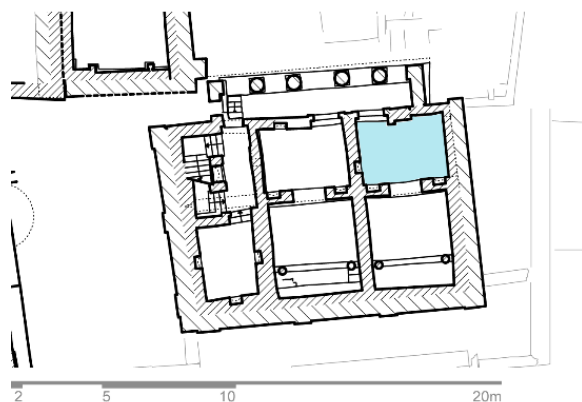
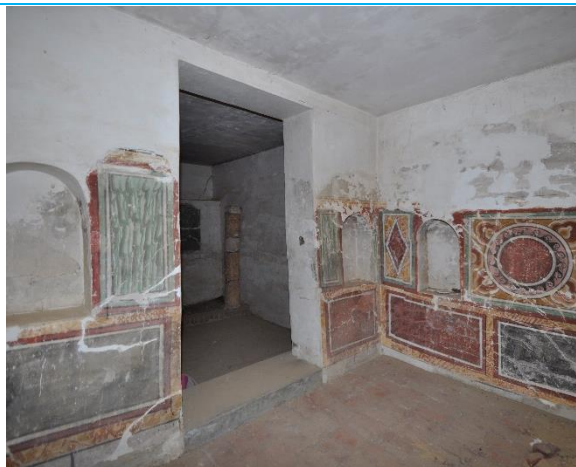
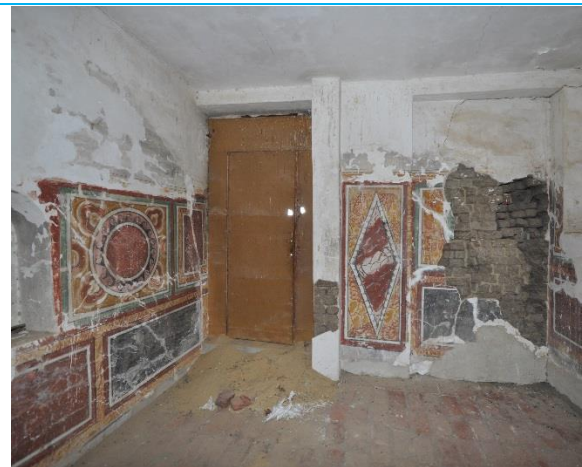
The plaster layers on the northern and eastern wall are partially lost and expose the sun dried clay brick masonry (adobe). Collapsed plaster fragments could be found on the floor. Where visible the adobe masonry shows a structurally destabilised and sanding surface. Parts of the joints are lost. In the northern-eastern corner is a hole in the wall bricked up with loses clay bricks.

The architectural surface is lined with cracks. The plaster layers are detached from the adobe masonry, being at high risk to falling off. Partially, the paint layers show deterioration phenomena like flaking and powdering. Dust covers all exposed surfaces.

An intervention is necessary to halt active deterioration and preserve the original plaster and wall painting.

The following steps of emergency measures were done in the field schools of 2012, 2014 and 2018. The architectural surface was dry cleaned by using soft brushes. For temporary protection fragile parts of the wall paintings were faced with Japanese paper. The many fallen-off plaster fragments were secured, documented and stored separately.
