Tomb no. GB 33 (Gabra no. M 20/SE) anteroom

Tomb no. GB 33 (Gabra no. M 20/SE) main room

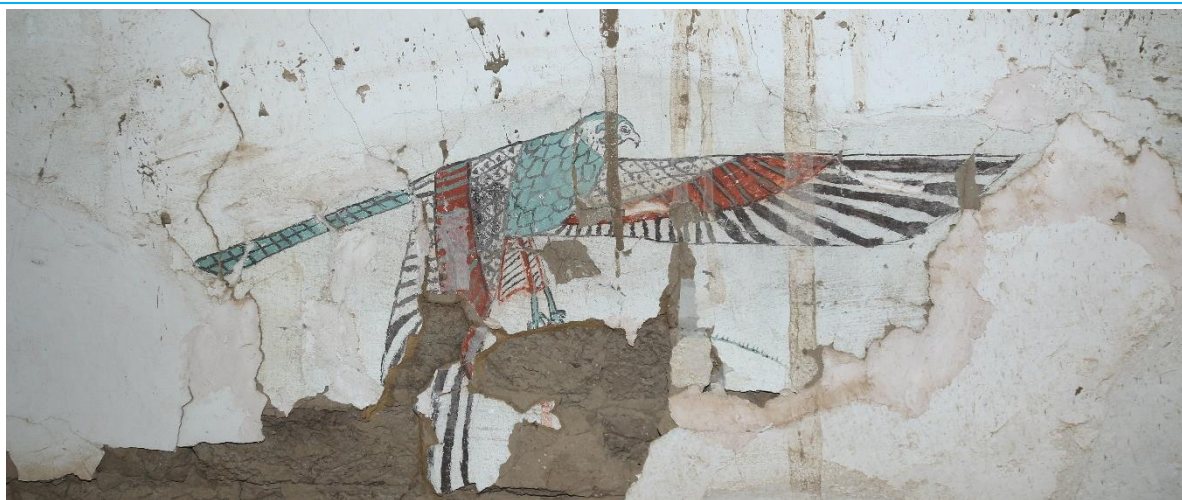
Condition after treatment

Parts of the most vulnerable areas of the artwork could be stabilized. Fragile parts of the wall paintings, which could not be consolidated in the working campaigns, were faced with Japanese paper and cellulose-ether glue. Further treatment is essential to guarantee long-term conservation.

The tomb house is protected by a lockable door mostly covered by sand. In addition, the tomb house window was provided with a new netting wire cover to prevent animals from nesting inside. For the future it would be desirable to establish a maintenance and monitoring programme.
